## General Information

| Make | Honda | Model | City |
| YOM | 2018 | Odo Meter Reading | 83,435 |
| Registration No. | NAK6561 | Chassis No. | PADGM6630JV415595 |

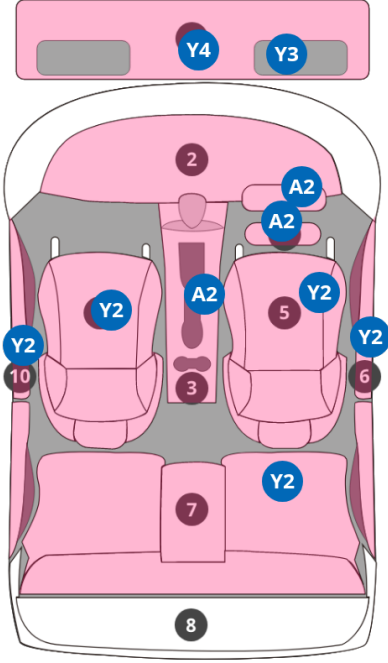
| Interior Evaluation : <span style="color: red;">C</span> | Exterior Evaluation : <span style="color: red;">D</span> |
|---|---|
| <b>Remarks</b><br>Ceiling - Grime - Large / Sunvisor, Sunglass Holder - Grime - Medium / (R) Front Trim - Grime - Small / (R) Front Seat - Grime - Small / (L) Front Seat - Grime - Small / (L) Front Trim - Grime - Small / Rear Seat - Grime - Small / Knobs - Worn, Peel, Crack - Small / Carpet - Worn, Scratch, Cut, Crack - Small / Steering Wheel - Worn, Peel, Crack - Small | <b>Remarks</b><br>(R) Front Door - Repair Traces - Yes / (R) Step - Replaced - Yes / (R) Step - Repair Traces - Yes / (R) Front Fender - Repair Traces - Yes / Bonnet - Repair Traces - Yes / (L) Front Fender - Repair Traces - Yes / (L) Front Door - Repair Traces - Yes / (L) Step - Repair Traces - Yes / (L) Rear Door - Repair Traces - Yes / (L) Rear Fender - Repair Traces - Yes / Trunk Hood, Rear Gate - Repair Traces - Yes / (R) Rear Fender - Repair Traces - Yes / (R) Rear Door - Repair Traces - Yes / Roof - Repair Traces - Yes / (L) Rear Fender, Molding - Scratch & Dent - Medium / (L) Front Door, Molding - Scratch & Dent - Medium / (L) Rear Door, Molding - Scratch - Small / (L) Front Fender, Molding - Crack, Gap - Medium / Front Bumper, Grille, Lamps - Rust, Corrosion - Medium / (R) Mirror - Scratch, Peeled - Yes / Roof Spoiler, Molding - Rust, Corrosion - Small / (R) Step, In-panel, Side Spoiler - Crack, Gap - Medium / (R) Rear Door, Molding - Repair mark - Yes / (R) Rear Fender, Molding - Repair mark - Yes / (L) Rear Fender, Molding - Partially Missing - Yes / Rear Bumper, Lamps, Panels - Scratch - Small / Overall Exterior - Full Re-Paint in same color - Yes |
