## General Information

| Make | Suzuki | Model | APV |
| YOM | 2019 | Odo Meter Reading | 49,088 |
| Registration No. | GAL1888 | Chassis No. | MHYDN71V7LJ400265 |

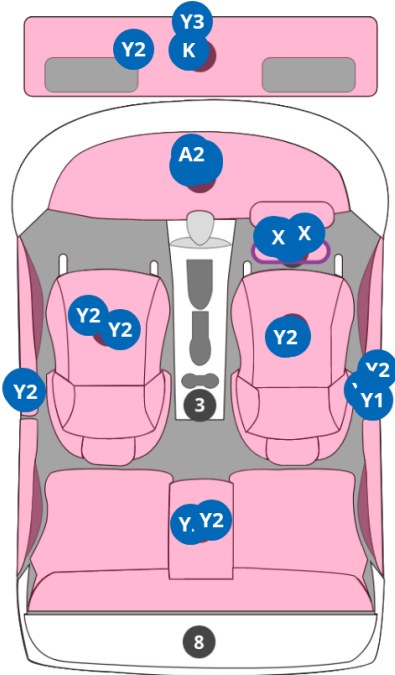
| Interior Evaluation : <span style="color: red;">E</span> | Exterior Evaluation : <span style="color: red;">E</span> |
| <p><b>Remarks</b></p> <p>Overall Interior - Animal Hair - Yes / Dashboard - Repair Mark - Yes / Glove Box - Worn, Scratch, Cut, Crack - Small / Instrument Panel - Repair Mark - Yes / Steering Wheel - Worn, Peel, Crack - Small / Carpet - Worked - Minimal / (R) Front Floor Mat - Missing - Yes / (L) Front Floor Mat - Missing - Yes / Mat Other - Missing - Yes / (R) Front Seat - Grime - Small / (R) Front Seat belt - Grime - Small / (L) Front Seat - Grime - Small / (L) Front Seat belt - Grime - Small / (L) Front Trim - Grime - Small / (L) Rear Trim - Grime - Small / (R) Front Trim - Grime - Small / (R) Rear Trim - Grime - Small / Trim Other - Grime - Minimal / Rear Seat - Grime - Small / Seat belt Other - Grime - Small / Sunvisor, Sunglass Holder - Grime - Medium / Ceiling - Grime - Small</p> | <p><b>Remarks</b></p> <p>(R) Front Door - Repair Traces - Yes / (R) Front Fender - Repair Traces - Yes / Bonnet - Repair Traces - Yes / (L) Front Fender - Repair Traces - Yes / (L) Front Door - Repair Traces - Yes / (L) Rear Door - Repair Traces - Yes / (L) Rear Fender - Repair Traces - Yes / Trunk Hood, Rear Gate - Repair Traces - Yes / (R) Rear Fender - Repair Traces - Yes / (R) Rear Door - Repair Traces - Yes / Roof - Repair Traces - Yes / Overall Exterior - Full Re-Paint in same color - Yes / Front Bumper, Grille, Lamps - Scratch &amp; Dent - Large / Bonnet, Headlight - Scratch - Small / (L) Front Fender, Molding - Scratch &amp; Dent - Medium / Supplemental Mirror - Scratch, Peeled - Minimal / (L) Front Wheel, Cover - Scratch, Corrosion - Small / (L) Front Door, Molding - Scratch - Small / (L) Rear Door, Molding - Scratch &amp; Dent - Medium / (L) Mirror - Scratch - Small / (L) Side Window - Scratch, Stone chip - Medium / (L) Rear Fender, Molding - Scratch - Small / (L) Rear Wheel, Cover - Scratch, Corrosion - Small / Muffler and Undercarriage Parts - Rust - Yes / Trunk Hood, Rear Gate - Scratch &amp; Dent - Small / Rear Bumper, Lamps, Panels - Scratch &amp; Dent - Large / (R) Rear Fender, Molding - Scratch - Small / (R) Rear Wheel, Cover - Scratch, Corrosion - Small / (R) Rear Door, Molding - Scratch &amp; Dent - Large / (R) Front Door, Molding - Scratch - Small / (R) Step, In-panel, Side Spoiler - Scratch - Small / (R) Front Fender, Molding - Scratch &amp; Dent - Small / Roof - Scratch &amp; Dent - Small / Front Windshield - Scratch, Stone chip - Small</p> |

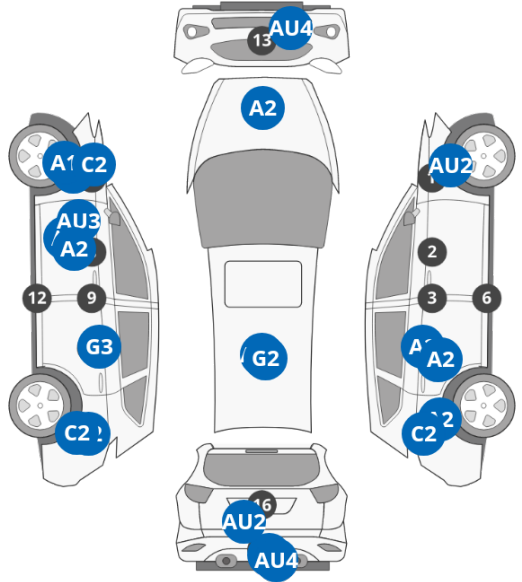
| Interior Evaluation : <span style="color: red;">E</span> | Exterior Evaluation : <span style="color: red;">E</span> |
|---|---|
| <p><b>a</b> : Cut, Fray <b>d</b> : Loose, Deformed <b>k</b> : Animal Hair <b>s</b> : Smell <b>t</b> : Cigarette Burns <b>x</b> : Defective <b>y</b> : Stain</p> | <p><b>A</b> : Scratch <b>AU</b> : Scratch &amp; Dent <b>B</b> : Modified <b>C</b> : Corrosion <b>G</b> : Stone chip <b>P</b> : Faded <b>S</b> : Rust <b>SC</b> : Rust &amp; Corrosion <b>U</b> : Dent <b>X</b> : Defective <b>Y</b> : Crack, Gap</p> |

Transmission issue. right headlight busted. Front room lamp issue and audio not working. Door lock switch issue. and without room lamp cover, Repaired right side mirror. Possible flooding. Watermarks at headlight. Both taillight busted. Paintmarks at bonnet. Without warranty booklet, seatcover, Tools and Jack. With LTO plate and 1 key.
