## General Information

| Make | Toyota | Model | Vios |

## Body / Panel Condition

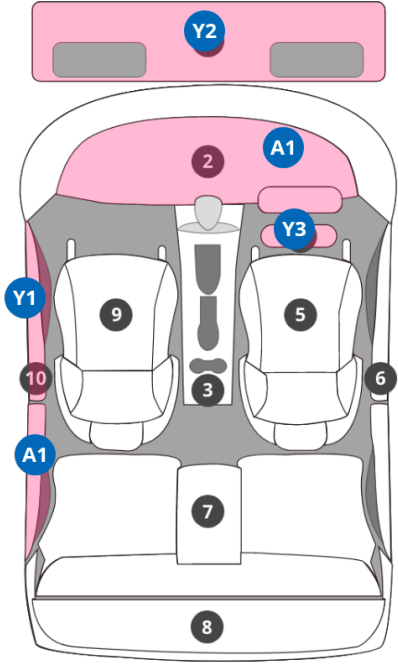
| Interior Evaluation : <b>B</b> | Exterior Evaluation : <b>C</b> |
| <p><b>Remarks</b><br/>Ceiling - Grime - Small / Mat Other - Grime - Medium / (L) Front Trim - Grime - Minimal / (L) Rear Trim - Cut, Crack - Minimal / Dashboard - Worn, Scratch, Cut, Crack - Minimal</p> | <p><b>Remarks</b><br/>(R) Front Fender, Molding - Scratch - Minimal / (R) Mirror - Scratch - Minimal / (R) Front Door, Molding - Scratch &amp; Dent - Minimal / (R) Step, In-panel, Side Spoiler - Scratch &amp; Dent - Small / (R) Rear Door, Molding - Scratch - Minimal / (R) Rear Fender, Molding - Scratch - Small / Rear Bumper, Lamps, Panels - Scratch &amp; Dent - Small / Trunk Hood, Rear Gate - Dent - Minimal / (L) Rear Fender, Molding - Scratch - Minimal / Roof Spoiler, Molding - Dent - Minimal / Roof - Scratch &amp; Dent - Minimal / (L) Rear Door, Molding - Scratch - Minimal / (L) Mirror - Scratch - Minimal / (L) Step, In-panel, Side Spoiler - Scratch &amp; Dent - Minimal / (L) Front Door, Molding - Scratch - Minimal / (L) Front Fender, Molding - Scratch - Minimal / Front Bumper, Grille, Lamps - Scratch &amp; Dent - Large / Bonnet, Headlight - Scratch - Minimal</p> |
