## General Information

| Make | Toyota | Model | Vios |
| YOM | 2023 | Odo Meter Reading | 39,699 |
| Registration No. | EAG2167 | Chassis No. | PA1B18F36P4202693 |

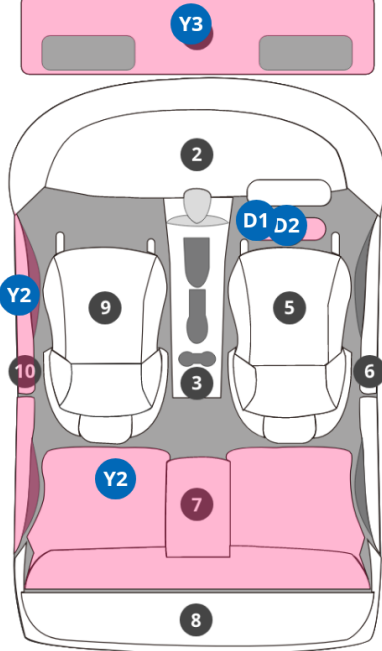
| Interior Evaluation : <b>B</b> | Exterior Evaluation : <b>D</b> |
| <p><b>Remarks</b></p> <p>Ceiling - Grime - Medium / (L) Front Trim - Grime - Small / (L) Front Floor Mat - Worked - Small / Carpet - Worked - Minimal / Rear Seat - Grime - Small</p> | <p><b>Remarks</b></p> <p>Trunk Hood, Rear Gate - Repair Traces - Yes / (R) Front Fender, Molding - Scratch &amp; Dent - Minimal / (R) Mirror - Scratch - Minimal / (R) Front Door, Molding - Scratch &amp; Dent - Minimal / (R) Rear Door, Molding - Scratch - Minimal / (R) Rear Fender, Molding - Scratch &amp; Dent - Minimal / Rear Bumper, Lamps, Panels - Scratch - Large / (L) Rear Fender, Molding - Scratch &amp; Dent - Minimal / (L) Rear Door, Molding - Scratch &amp; Dent - Large / (L) Step, In-panel, Side Spoiler - Scratch - Minimal / (L) Front Door, Molding - Scratch - Medium / Roof Spoiler, Molding - Scratch - Minimal / Roof - Scratch - Minimal / (L) Mirror - Scratch - Minimal / (L) Front Fender, Molding - Scratch - Minimal / Front Bumper, Grille, Lamps - Scratch &amp; Dent - Large / Bonnet, Headlight - Scratch - Small / (R) Step, In-panel, Side Spoiler - Scratch - Minimal / Trunk Hood, Rear Gate - Scratch &amp; Dent - Medium</p> |

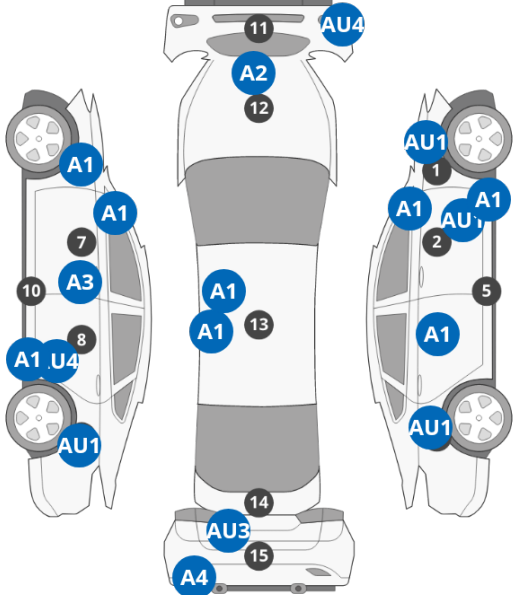
| Inspector Notes |
|---|
| With Lto plate, with warranty booklet and jack, 1key, no spare tire and tools, scratches on headlights and taillights, |
