## General Information

| Make | Toyota | Model | Vios |

## Body / Panel Condition

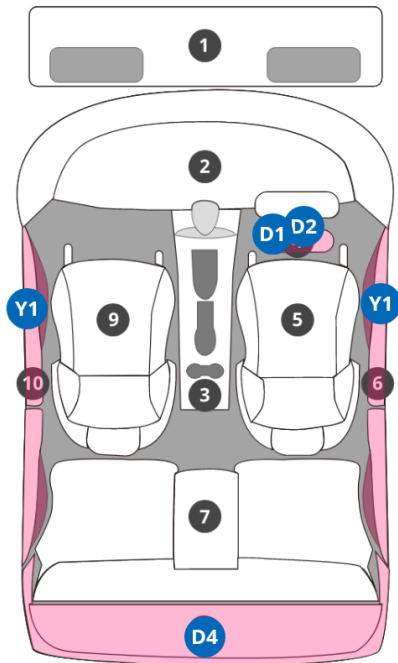
| Interior Evaluation : <span style="color: red;">C</span> | Exterior Evaluation : <span style="color: red;">C</span> |
| <b>Remarks</b><br>Trunk Room - Loose, Deformed - Large / (R) Front Trim - Grime - Minimal / (L) Front Floor Mat - Worked - Small / Carpet - Worked - Minimal / (L) Front Trim - Grime - Minimal | <b>Remarks</b><br>(R) Front Fender, Molding - Scratch - Minimal / (R) Mirror - Scratch - Minimal / (R) Front Door, Molding - Scratch - Minimal / (R) Rear Door, Molding - Scratch & Dent - Small / (R) Step, In-panel, Side Spoiler - Scratch - Minimal / (R) Rear Fender, Molding - Scratch - Small / Roof - Scratch - Minimal / Rear Bumper, Lamps, Panels - Scratch - Small / Trunk Hood, Rear Gate - Scratch - Small / (L) Rear Fender, Molding - Scratch - Minimal / (L) Rear Door, Molding - Scratch - Minimal / (L) Front Door, Molding - Scratch - Minimal / (L) Front Fender, Molding - Scratch - Minimal / Front Bumper, Grille, Lamps - Scratch & Dent - Large / Bonnet, Headlight - Scratch - Small / (L) Step, In-panel, Side Spoiler - Scratch - Minimal |
