## General Information

| Make | Toyota | Model | Vios |
| YOM | 2026 | Odo Meter Reading | 43,891 |

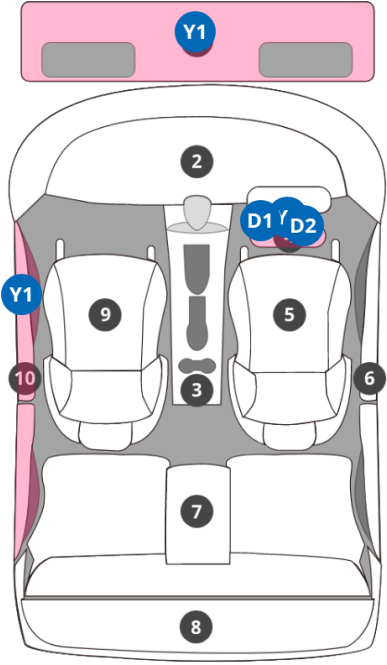
| Interior Evaluation : <span style="color: red;">A</span> | Exterior Evaluation : <span style="color: red;">D</span> |
| <b>Remarks</b><br>Ceiling - Grime - Minimal / (R) Front Floor Mat - Grime - Minimal / (L) Front Trim - Grime - Minimal / (L) Front Floor Mat - Worked - Small / Carpet - Worked - Minimal | <b>Remarks</b><br>(R) Front Fender, Molding - Scratch & Dent - Large / (R) Front Door, Molding - Scratch & Dent - Large / (R) Rear Door, Molding - Scratch & Dent - Large / (R) Step, In-panel, Side Spoiler - Scratch - Minimal / (R) Rear Fender, Molding - Scratch & Dent - Minimal / Trunk Hood, Rear Gate - Scratch - Minimal / Rear Bumper, Lamps, Panels - Scratch - Minimal / (L) Rear Fender, Molding - Dent - Medium / (L) Rear Door, Molding - Scratch - Medium / (L) Front Door, Molding - Scratch & Dent - Minimal / (L) Front Fender, Molding - Scratch & Dent - Minimal / Front Bumper, Grille, Lamps - Scratch - Medium / Bonnet, Headlight - Scratch & Dent - Minimal |

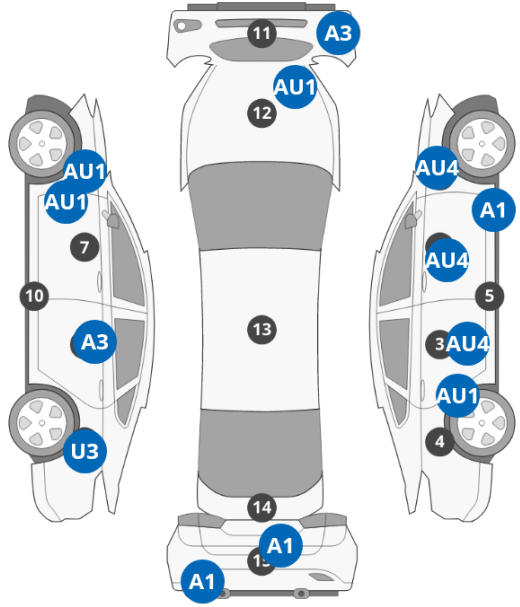
With Lto plate, with spare tire, with jack and tools, 1key, no warranty booklet, scratches on headlights and taillights, left fender light issue, cover under hood missing, hood stand issue
