## General Information

| Make | Toyota | Model | Vios |
| YOM | 2026 | Odo Meter Reading | 6,357 |
| Registration No. | NJK4969 | Chassis No. | PA1B18F3X4299728 |

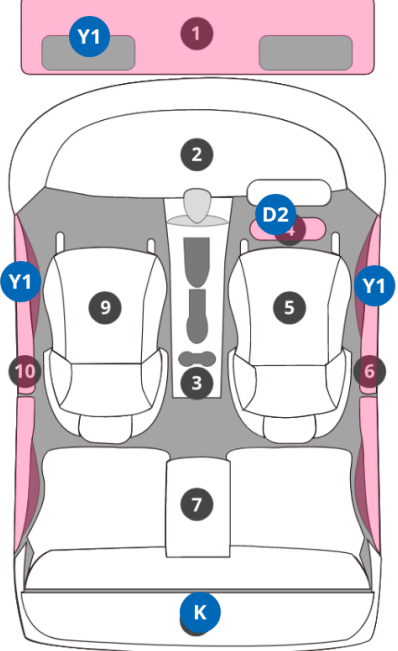
| Interior Evaluation : <b>B</b> | Exterior Evaluation : <b>C</b> |
| <p><b>Remarks</b><br/>Sunvisor, Sunglass Holder - Grime - Minimal / Overall Interior - Animal Hair - Yes / (L) Front Floor Mat - Worked - Small / (L) Front Trim - Grime - Minimal / (R) Front Trim - Grime - Minimal</p> | <p><b>Remarks</b><br/>(R) Front Fender, Molding - Scratch - Minimal / (R) Front Door, Molding - Scratch - Minimal / (R) Rear Door, Molding - Scratch &amp; Dent - Large / (R) Rear Fender, Molding - Scratch &amp; Dent - Small / Trunk Hood, Rear Gate - Scratch - Minimal / Rear Bumper, Lamps, Panels - Scratch - Minimal / (L) Rear Fender, Molding - Scratch - Minimal / (L) Rear Door, Molding - Scratch - Minimal / (L) Front Door, Molding - Scratch &amp; Dent - Minimal / (L) Front Fender, Molding - Scratch - Minimal / Front Bumper, Grille, Lamps - Scratch &amp; Dent - Minimal / Bonnet, Headlight - Scratch - Minimal</p> |

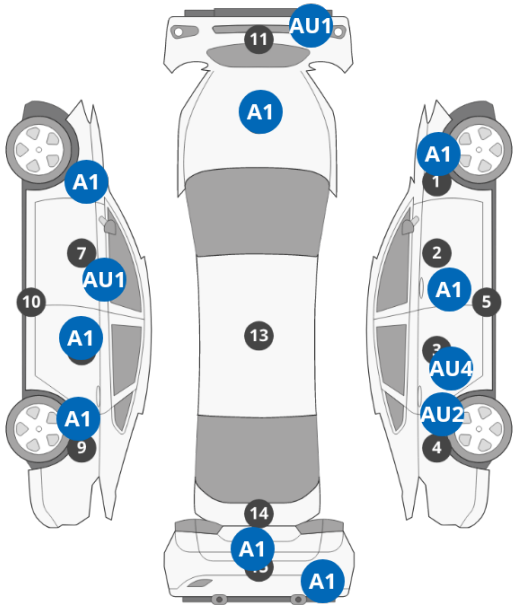
| Inspector Notes |
|---|
| With Lto plate, with jack and tools, with warranty booklet, 1key, no spare tire, scratches on headlights and taillights |
