## General Information

| Make | Toyota | Model | Vios |
| YOM | 2024 | Odo Meter Reading | 27,545 |

## Body / Panel Condition

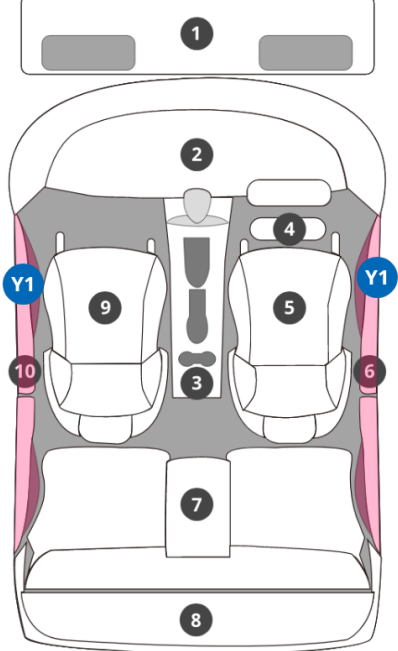
| Interior Evaluation : <b>A</b> | Exterior Evaluation : <b>E</b> |
| <p><b>Remarks</b><br/>(R) Front Trim - Grime - Minimal / (L) Front Trim - Grime - Minimal</p> | <p><b>Remarks</b><br/>(R) Front Fender, Molding - Scratch - Minimal / (R) Front Door, Molding - Scratch - Minimal / (R) Rear Door, Molding - Scratch - Medium / (R) Mirror - Scratch - Minimal / (R) Step, In-panel, Side Spoiler - Scratch &amp; Dent - Medium / (R) Rear Fender, Molding - Scratch &amp; Dent - Medium / Trunk Hood, Rear Gate - Scratch - Minimal / Rear Bumper, Lamps, Panels - Scratch - Small / (L) Rear Fender, Molding - Scratch - Medium / (L) Rear Door, Molding - Scratch - Large / (L) Front Door, Molding - Scratch - Large / (L) Step, In-panel, Side Spoiler - Scratch - Minimal / (L) Front Fender, Molding - Scratch - Small / Member (Bolted) - Dent - Yes / Front Bumper, Grille, Lamps - Scratch &amp; Dent - Large / Bonnet, Headlight - Scratch - Medium / Roof - Scratch &amp; Dent - Minimal</p> |

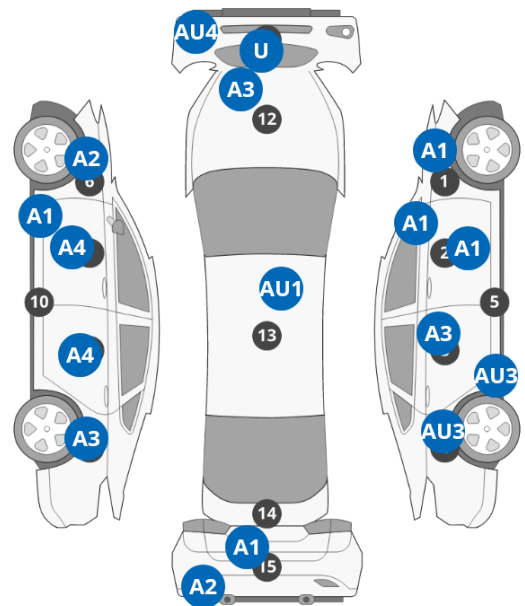
| Inspector Notes |
|---|
| With Lto plate, with warranty booklet and tools, with jack, 2keys, no spare tire, scratches on headlights and taillights, battery weak |
