## General Information

| Make | Toyota | Model | Supra |
| Registration No. | GAV5586 | Chassis No. | WZ1DB41000W023908 |

## Body / Panel Condition

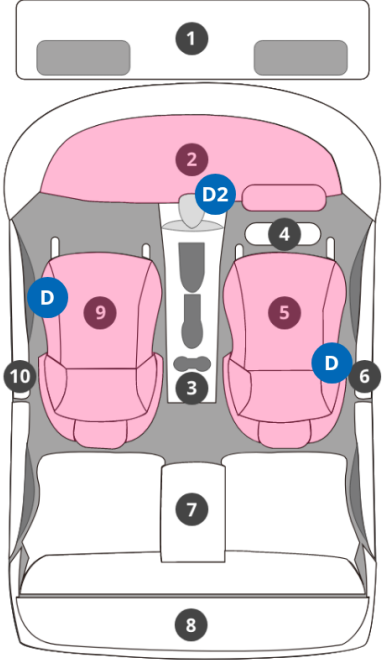
| Interior Evaluation : <b>B</b> | Exterior Evaluation : <b>B</b> |
|---|---|
| <p><b>Remarks</b><br/>(L) Front Seat - Worn - Yes / (R) Front Seat - Worn - Yes / Dashboard - Loose, Deformed - Small</p> | <p><b>Remarks</b><br/>(L) Rear Fender, Molding - Scratch &amp; Dent - Small / Front Bumper, Grille, Lamps - Scratch &amp; Dent - Medium / Rear Bumper, Lamps, Panels - Scratch &amp; Dent - Small / (L) Front Door, Molding - Scratch - Small / (L) Step, In-panel, Side Spoiler - Crack, Gap - Small / (R) Step, In-panel, Side Spoiler - Crack, Gap - Small</p> |
