## General Information

| Make | Toyota | Model | Vios |
| YOM | 2022 | Odo Meter Reading | 95,432 |

## Body / Panel Condition

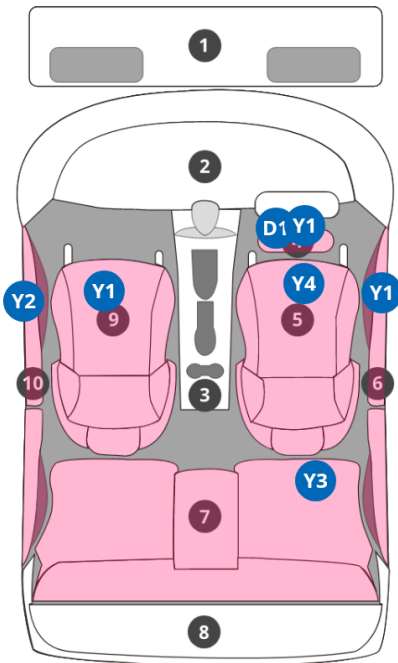
| <b>Interior Evaluation :</b> <span style="color: red; font-weight: bold;">C</span> | <b>Exterior Evaluation :</b> <span style="color: red; font-weight: bold;">D</span> |
| <b>Remarks</b><br>(R) Front Seat - Grime - Large / (R) Front Trim - Grime - Minimal / Rear Seat - Grime - Medium / (L) Front Trim - Grime - Small / (L) Front Seat - Grime - Minimal / Carpet - Worked - Minimal / (L) Front Floor Mat - Grime - Minimal | <b>Remarks</b><br>(R) Front Door - Repair Traces - Yes / (R) Front Fender - Repair Traces - Yes / Bonnet - Repair Traces - Yes / (L) Front Fender - Repair Traces - Yes / (L) Front Door - Repair Traces - Yes / (L) Rear Door - Repair Traces - Yes / (L) Rear Fender - Repair Traces - Yes / Trunk Hood, Rear Gate - Repair Traces - Yes / (R) Rear Fender - Repair Traces - Yes / (R) Rear Door - Repair Traces - Yes / Roof - Repair Traces - Yes / Overall Exterior - Re-Paint Uneven - Yes / (R) Front Fender, Molding - Repair mark - Yes / (R) Mirror - Scratch - Minimal / (R) Front Fender, Molding - Scratch & Dent - Minimal / (R) Front Door, Molding - Repair mark - Yes / (R) Front Door, Molding - Scratch & Dent - Minimal / (R) Step, In-panel, Side Spoiler - Dent - Medium / (R) Rear Door, Molding - Repair mark - Yes / (R) Rear Door, Molding - Scratch - Minimal / (R) Rear Fender, Molding - Repair mark - Yes / (R) Rear Fender, Molding - Scratch - Minimal / Roof - Scratch - Minimal / Rear Bumper, Lamps, Panels - Scratch - Medium / Trunk Hood, Rear Gate - Scratch - Small / (L) Rear Fender, Molding - Scratch & Dent - Minimal / (L) Rear Door, Molding - Repair mark - Yes / (L) Rear Door, Molding - Dent - Minimal / (L) Front Door, Molding - Scratch & Dent - Minimal / Roof Spoiler, Molding - Scratch - Minimal / (L) Mirror - Scratch - Minimal / (L) Step, In-panel, Side Spoiler - Scratch - Minimal / (L) Front Fender, Molding - Scratch - Minimal / Bonnet, Headlight - Scratch - Small / Front Bumper, Grille, Lamps - Scratch & Dent - Minimal |

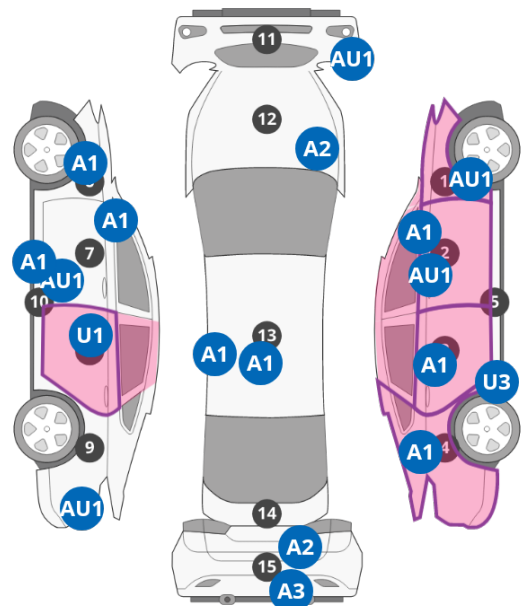
With Lto plate, with spare tire and jack, 1key, no warranty booklet and tools, scratches on headlights and taillights, battery weak, R fender lights issue
