## General Information

| Make | Nissan | Model | Almera |
| YOM | 2017 | Odo Meter Reading | 40,394 |
| Registration No. | CAD1594 | Chassis No. | BDUALGAN17B77756 |

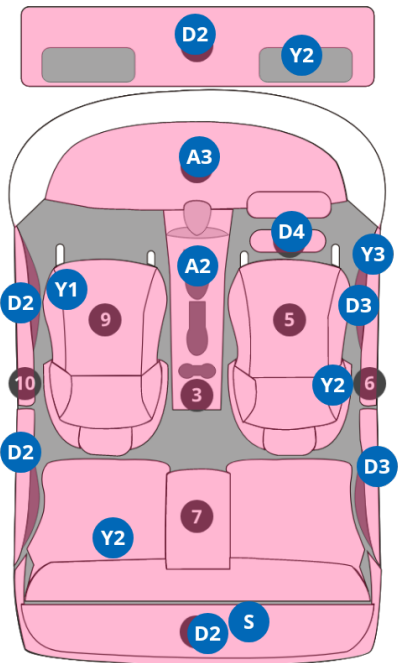
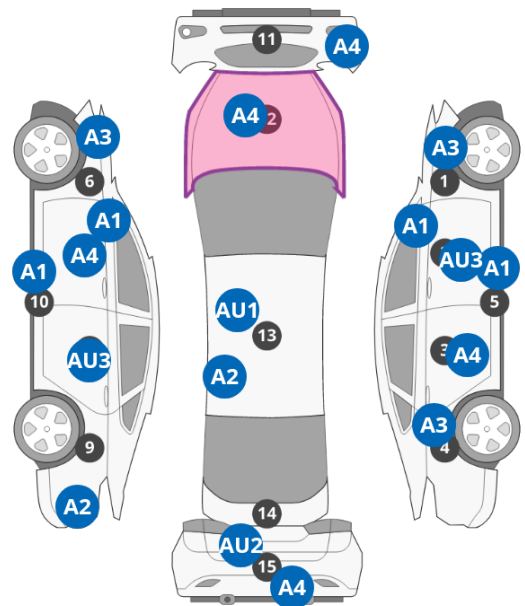
| Interior Evaluation : <span style="color: red;">E</span> | Exterior Evaluation : <span style="color: red;">E</span> |
| <p><b>a</b> : Cut, Fray <b>d</b> : Loose, Deformed <b>k</b> : Animal Hair <b>s</b> : Smell <b>t</b> : Cigarette Burns <b>x</b> : Defective <b>y</b> : Stain</p> | <p><b>A</b> : Scratch <b>AU</b> : Scratch &amp; Dent <b>B</b> : Modified <b>C</b> : Corrosion <b>G</b> : Stone chip <b>P</b> : Faded <b>S</b> : Rust <b>SC</b> : Rust &amp; Corrosion <b>U</b> : Dent <b>X</b> : Defective <b>Y</b> : Crack, Gap</p> |
| <b>Remarks</b><br>Ceiling - Loose, Deformed - Small / (R) Rear Trim - Loose, Deformed - Medium / (R) Front Trim - Loose, Deformed - Medium / Trim Other - Grime - Medium / Carpet - Worked - Large / Trunk Room - Loose, Deformed - Small / (L) Rear Trim - Loose, Deformed - Small / Rear Seat - Grime - Small / (L) Front Trim - Loose, Deformed - Small / Steering Wheel - Worn, Peel, Crack - Medium / Knobs - Worn, Peel, Crack - Small / Sunvisor, Sunglass Holder - Grime - Small / (L) Front Seat - Grime - Minimal / Overall Interior - Smell - Yes / (R) Front Seat belt - Grime - Small / Overall Interior - Worn as per age - Yes | <b>Remarks</b><br>(R) Front Door - Repair Traces - Yes / (R) Front Fender - Repair Traces - Yes / Bonnet - Repair Traces - Yes / (L) Front Fender - Repair Traces - Yes / (L) Front Door - Repair Traces - Yes / (L) Rear Door - Repair Traces - Yes / (L) Rear Fender - Repair Traces - Yes / Trunk Hood, Rear Gate - Repair Traces - Yes / (R) Rear Fender - Repair Traces - Yes / (R) Rear Door - Repair Traces - Yes / Roof - Repair Traces - Yes / (R) Front Fender, Molding - Scratch - Medium / (R) Mirror - Scratch - Minimal / (R) Step, In-panel, Side Spoiler - Scratch - Minimal / (R) Rear Door, Molding - Scratch - Large / (R) Front Door, Molding - Scratch & Dent - Medium / (R) Rear Fender, Molding - Scratch - Medium / Rear Bumper, Lamps, Panels - Scratch - Large / Trunk Hood, Rear Gate - Scratch & Dent - Small / (L) Rear Fender, Molding - Scratch - Small / (L) Rear Door, Molding - Scratch & Dent - Medium / Roof - Scratch & Dent - Minimal / Roof Spoiler, Molding - Scratch - Small / (L) Step, In-panel, Side Spoiler - Scratch - Minimal / (L) Front Door, Molding - Scratch - Large / (L) Mirror - Scratch - Minimal / (L) Front Fender, Molding - Scratch - Medium / Front Bumper, Grille, Lamps - Scratch - Large / Bonnet, Headlight - Repair mark - Yes / Bonnet, Headlight - Scratch - Large |
