## General Information

| Make | Toyota | Model | Yaris Cross |

## Body / Panel Condition

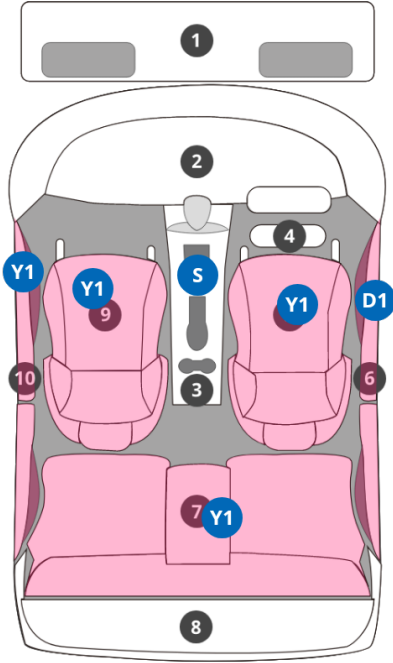
| Interior Evaluation : <b>A</b> | Exterior Evaluation : <b>B</b> |
|---|---|
| <p><b>Remarks</b><br/>(L) Front Seat - Grime - Minimal / (R) Front Seat - Grime - Minimal / Rear Seat - Grime - Minimal / (L) Front Trim - Grime - Minimal / (R) Front Trim - Crinkle - Minimal</p> | <p><b>Remarks</b><br/>(R) Front Fender - Repair Traces - Yes / (R) Rear Fender, Molding - Scratch - Minimal / (R) Rear Door, Molding - Scratch - Small / (R) Front Fender, Molding - Scratch &amp; Dent - Minimal / Bonnet, Headlight - Scratch - Small / (L) Front Fender, Molding - Scratch - Small / (L) Front Door, Molding - Scratch &amp; Dent - Minimal / (L) Rear Door, Molding - Scratch &amp; Dent - Small / (L) Rear Fender, Molding - Scratch &amp; Dent - Minimal / Trunk Hood, Rear Gate - Scratch &amp; Dent - Small / Rear Bumper, Lamps, Panels - Scratch - Small / (R) Front Door, Molding - Scratch - Minimal / Roof - Scratch - Small / Front Bumper, Grille, Lamps - Scratch &amp; Dent - Minimal</p> |

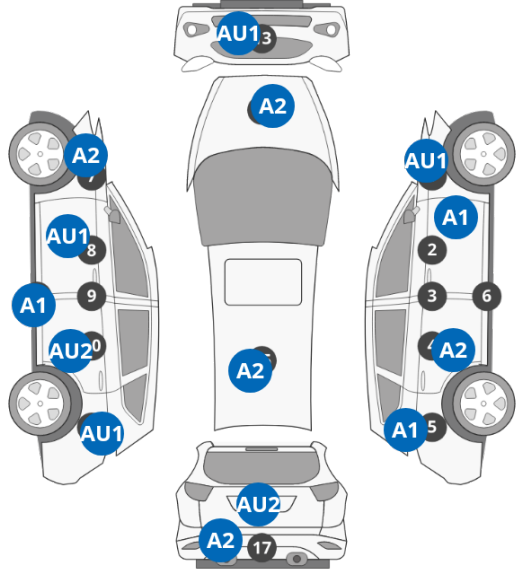
with LTO plate, with warranty and manual booklet, with reverse camera , with spare tire and key, no jack and tools, scratches on taillight and headlight, minor scratches on exterior.
