## General Information

| Make | Toyota | Model | Innova |
| Registration No. | NIM2973 | Chassis No. | PA2JA8EM3P0122213 |

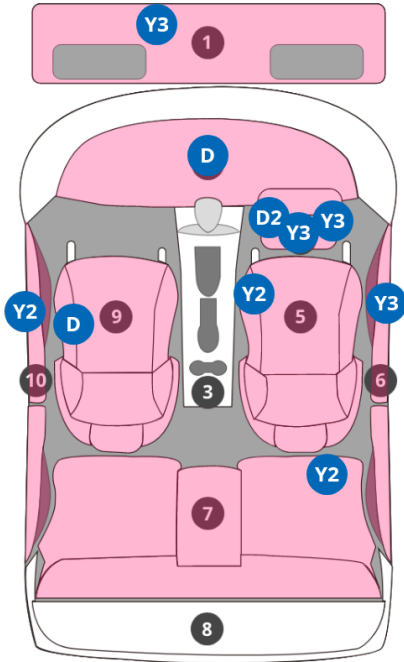
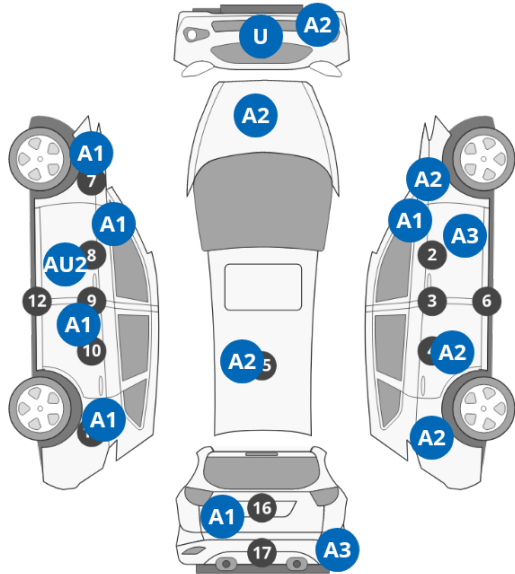
| <p><b>a</b> : Cut, Fray <b>d</b> : Loose, Deformed <b>k</b> : Animal Hair <b>s</b> : Smell <b>t</b> : Cigarette Burns <b>x</b> : Defective <b>y</b> : Stain</p> | <p><b>A</b> : Scratch <b>AU</b> : Scratch &amp; Dent <b>B</b> : Modified <b>C</b> : Corrosion <b>G</b> : Stone chip <b>P</b> : Faded <b>S</b> : Rust <b>SC</b> : Rust &amp; Corrosion <b>U</b> : Dent <b>X</b> : Defective <b>Y</b> : Crack, Gap</p> |
| <b>Remarks</b><br>Dashboard - Traces of Adhesive Tape - Yes / (L) Front Trim - Grime - Small / (R) Front Trim - Grime - Medium / (R) Front Seat - Grime - Small / (L) Front Seat - Worn - Yes / Rear Seat - Grime - Small / Ceiling - Grime - Medium / (L) Front Floor Mat - Worked - Small / (R) Front Floor Mat - Grime - Medium / Mat Other - Grime - Medium | <b>Remarks</b><br>(R) Front Fender - Repair Traces - Yes / Bonnet - Repair Traces - Yes / (L) Front Fender - Repair Traces - Yes / Roof - Repair Traces - Yes / (R) Front Fender, Molding - Scratch - Small / (R) Mirror - Scratch - Minimal / (R) Front Door, Molding - Scratch - Medium / (R) Rear Door, Molding - Scratch - Small / (R) Rear Fender, Molding - Scratch - Small / Rear Bumper, Lamps, Panels - Scratch - Medium / Trunk Hood, Rear Gate - Scratch - Minimal / (L) Rear Fender, Molding - Scratch - Minimal / (L) Rear Door, Molding - Scratch - Minimal / (L) Front Door, Molding - Scratch & Dent - Small / (L) Mirror - Scratch - Minimal / (L) Front Fender, Molding - Scratch - Minimal / Member (Bolted) - Dent - Yes / Front Bumper, Grille, Lamps - Scratch - Small / Bonnet, Headlight - Scratch - Small / Roof - Scratch - Small |
