## General Information

| Make | Toyota | Model | Vios |

## Body / Panel Condition

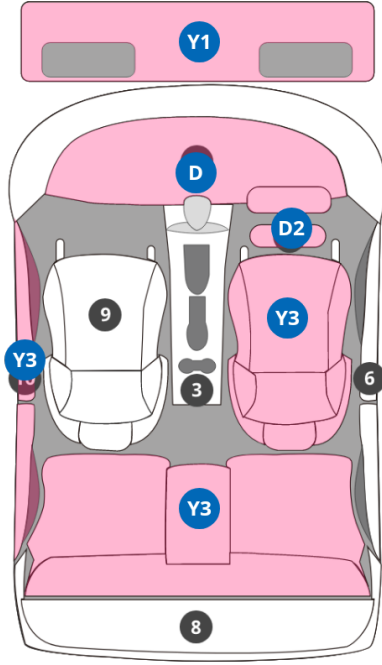
| Interior Evaluation : <b>B</b> | Exterior Evaluation : <b>D</b> |
| <p><b>Remarks</b></p> <p>(R) Front Seat - Grime - Medium / Rear Seat - Grime - Medium / (L) Front Floor Mat - Worked - Small / (L) Front Trim - Grime - Medium / Dashboard - Traces of Adhesive Tape - Yes / Ceiling - Grime - Minimal</p> | <p><b>Remarks</b></p> <p>(R) Rear Door, Molding - Scratch - Small / (R) Step, In-panel, Side Spoiler - Scratch &amp; Dent - Large / Trunk Hood, Rear Gate - Dent - Medium / Rear Bumper, Lamps, Panels - Scratch &amp; Dent - Medium / (L) Front Door, Molding - Scratch - Medium / (L) Front Fender, Molding - Scratch &amp; Dent - Medium / Front Bumper, Grille, Lamps - Scratch - Medium / Bonnet, Headlight - Scratch &amp; Dent - Minimal / (L) Rear Fender, Molding - Scratch - Minimal / (R) Rear Fender, Molding - Scratch - Minimal / (R) Mirror - Scratch - Medium</p> |
