## General Information

| Make | Toyota | Model | Vios |
| YOM | 2022 | Odo Meter Reading | 38,923 |

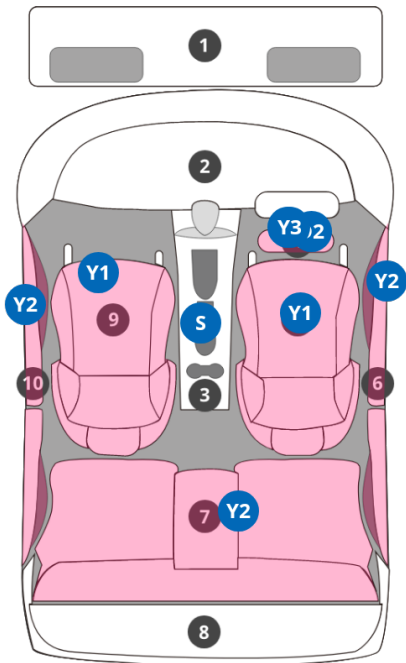
| Interior Evaluation : <b>B</b> | Exterior Evaluation : <b>E</b> |
|---|---|
| <p><b>Remarks</b></p> <p>Overall Interior - Smell - Yes / (L) Front Floor Mat - Crinkle - Small / (R) Front Floor Mat - Grime - Small / Mat Other - Grime - Medium / (L) Front Seat - Grime - Minimal / (R) Front Seat - Grime - Minimal / (L) Front Trim - Grime - Small / (R) Front Trim - Grime - Small / Rear Seat - Grime - Small</p> | <p><b>Remarks</b></p> <p>(R) Front Fender - Repair Traces - Yes / Bonnet - Repair Traces - Yes / (L) Front Fender - Repair Traces - Yes / (L) Rear Fender - Repair Traces - Yes / Trunk Hood, Rear Gate - Repair Traces - Yes / Rear End Panel - Repair Traces - Yes / Rear Bumper, Lamps, Panels - Repair mark - Yes / Trunk Hood, Rear Gate - Repair mark - Yes / (L) Rear Fender, Molding - Repair mark - Yes / (R) Rear Fender, Molding - Repair mark - Yes / Trunk Hood, Rear Gate - Scratch &amp; Dent - Small / Rear Bumper, Lamps, Panels - Scratch - Small / (R) Rear Fender, Molding - Scratch - Small / (R) Rear Door, Molding - Scratch &amp; Dent - Small / (R) Front Door, Molding - Scratch - Small / (R) Front Fender, Molding - Scratch &amp; Dent - Small / Bonnet, Headlight - Scratch &amp; Dent - Small / Roof - Scratch &amp; Dent - Small / (L) Rear Door, Molding - Scratch - Medium / (L) Rear Fender, Molding - Scratch &amp; Dent - Small / (L) Front Door, Molding - Scratch - Small / (L) Front Fender, Molding - Scratch &amp; Dent - Small / Front Bumper, Grille, Lamps - Scratch - Medium</p> |

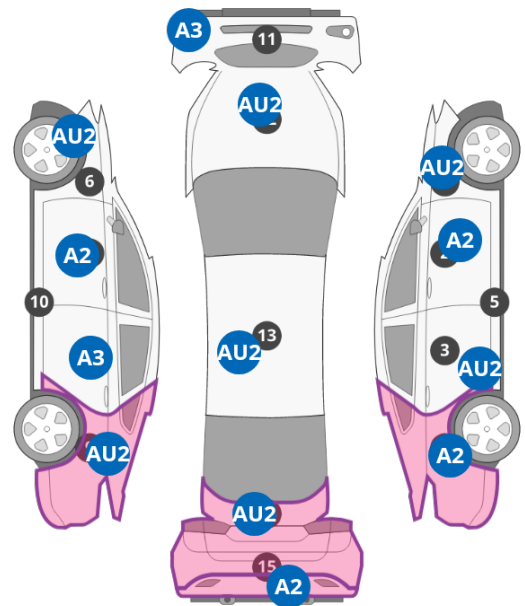
| Inspector Notes |
|---|
| with LTO plate, with jack, no reverse camera, no spare key, no spare tire, no tools, no warranty and manual booklet, scratches on exterior, scratches on taillight and headlight. |
