## General Information

| Make | Toyota | Model | Innova |
| Registration No. | AEA3177 | Chassis No. | KUN405108587 |

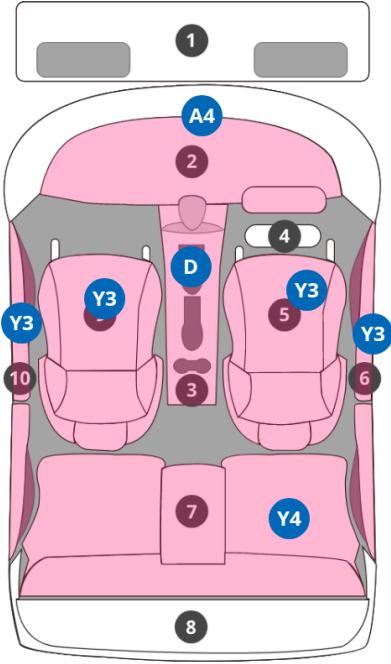
| <b>Interior Evaluation :</b> <b>D</b> | <b>Exterior Evaluation :</b> <b>N / A</b> |
| <b>Remarks</b><br>(R) Front Seat - Grime - Medium / Rear Seat - Grime - Large / (L) Front Seat - Grime - Medium / (R) Front Trim - Grime - Medium / (L) Front Trim - Grime - Medium / Dashboard - Worn, Scratch, Cut, Crack - Large / Console, Switchs, Vents - Repair Mark - Yes | <b>Remarks</b><br>Defects not found |
