## General Information

| Make | Toyota | Model | Veloz |
| YOM | 2024 | Mileage | 18,412 |

## Body / Panel Condition

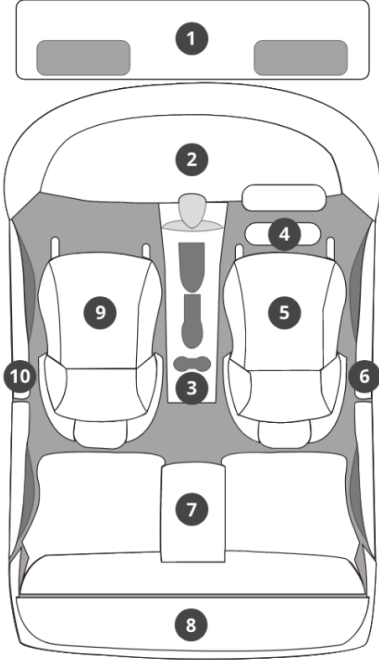
| Interior Evaluation : <b>A</b> | Exterior Evaluation : <b>B</b> |
| <b>Remarks</b><br>Defects not found | <b>Remarks</b><br>(R) Rear Door, Molding - Scratch & Dent - Small / (R) Rear Fender, Molding - Scratch & Dent - Medium / Rear Bumper, Lamps, Panels - Scratch - Medium / Front Bumper, Grille, Lamps - Scratch - Small |
