## General Information

| Make | Toyota | Model | Vios |

## Body / Panel Condition

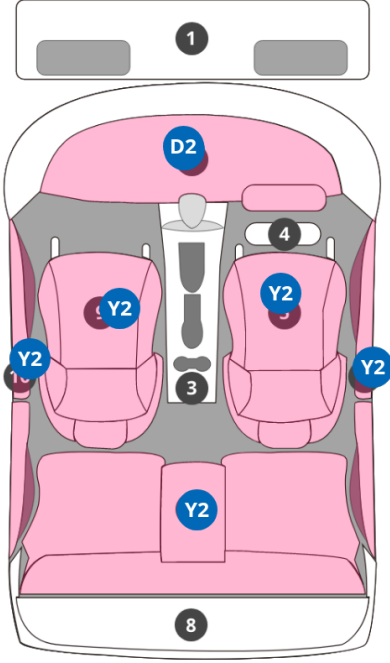
| Interior Evaluation : <b>B</b> | Exterior Evaluation : <b>E</b> |
|---|---|
| <b>Remarks</b><br>Dashboard - Worn, Scratch, Cut, Crack - Minimal / (R)<br>Front Seat - Grime - Small / (L) Front Seat - Grime - Small / Rear Seat - Grime - Small / (L) Front Trim - Grime - Small / (R) Front Trim - Grime - Small / Glove Box - Loose, Deformed - Small | <b>Remarks</b><br>(R) Front Fender, Molding - Scratch - Medium / (R) Mirror - Scratch - Minimal / (R) Front Door, Molding - Scratch - Large / (R) Step, In-panel, Side Spoiler - Scratch & Dent - Large / (R) Rear Door, Molding - Scratch - Large / (R) Rear Fender, Molding - Scratch - Medium / (L) Front Fender, Molding - Scratch - Small / (L) Mirror - Scratch - Minimal / (L) Front Door, Molding - Scratch - Medium / (L) Step, In-panel, Side Spoiler - Scratch - Small / (L) Rear Door, Molding - Dent - Small / (L) Rear Fender, Molding - Scratch - Small / Front Bumper, Grille, Lamps - Scratch & Dent - Medium / Bonnet, Headlight - Scratch & Dent - Medium / Roof - Scratch - Small / Trunk Hood, Rear Gate - Scratch - Small / Rear Bumper, Lamps, Panels - Scratch - Medium |
