## General Information

| Make | Chevrolet | Model | Trailblazer |

## Body / Panel Condition

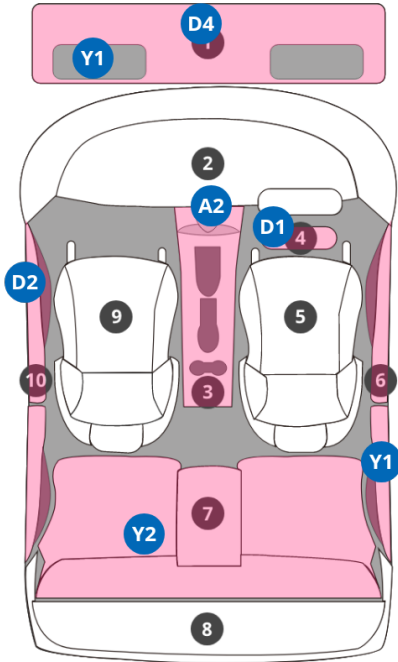
| Interior Evaluation : <span style="color: red;">C</span> | Exterior Evaluation : <span style="color: red;">E</span> |
| <b>Remarks</b><br>Sunvisor, Sunglass Holder - Grime - Minimal / Knobs - Worn, Peel, Crack - Small / (R) Rear Trim - Grime - Minimal / Rear Seat - Grime - Small / Ceiling - Loose, Deformed - Large / (L) Front Trim - Worked - Small / Carpet - Worked - Minimal | <b>Remarks</b><br>(L) Rear Fender - Repair Traces - Yes / (R) Front Fender, Molding - Scratch & Dent - Large / (R) Mirror - Scratch - Small / (R) Front Door, Molding - Scratch - Large / (R) Step, In-panel, Side Spoiler - Crack, Gap - Medium / (R) Rear Door, Molding - Scratch & Dent - Medium / (R) Rear Fender, Molding - Scratch - Small / Rear Bumper, Lamps, Panels - Scratch - Small / Trunk Hood, Rear Gate - Scratch - Minimal / (L) Rear Fender, Molding - Scratch - Small / (L) Rear Door, Molding - Scratch - Small / (L) Front Door, Molding - Scratch & Dent - Minimal / (L) Step, In-panel, Side Spoiler - Scratch - Minimal / (L) Mirror - Scratch - Minimal / (L) Front Fender, Molding - Scratch & Dent - Minimal / Front Bumper, Grille, Lamps - Scratch - Large / Bonnet, Headlight - Scratch & Dent - Large / Roof Spoiler, Molding - Crack, Gap - Large |
