## General Information

| Make | Nissan | Model | NV350 |
| Registration No. | NEJ6122 | Chassis No. | JNTC2E26Z0055561 |

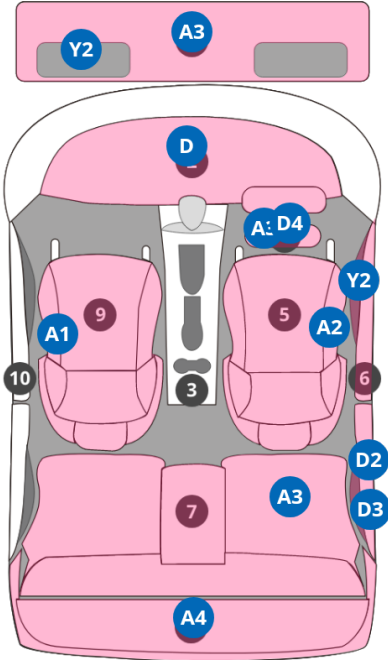
| Interior Evaluation : <b>E</b> | Exterior Evaluation : <b>E</b> |
|---|---|
| <p><b>Remarks</b></p> <p>Overall Interior - Worn as per age - Yes / Ceiling - Cut, Crack - Medium / (R) Front Trim - Grime - Small / (R) Front Seat - Cut, Crack - Small / (R) Rear Trim - Loose, Deformed - Small / Rear Seat - Cut, Crack - Medium / Trunk Room - Worn, Scratch, Cut, Crack - Large / Mat Other - Cut, Crack - Medium / Carpet - Worked - Large / (L) Front Seat - Cut, Crack - Minimal / Dashboard - Traces of Adhesive Tape - Yes / Sunvisor, Sunglass Holder - Grime - Small / Trim Other - Loose, Deformed - Medium</p> | <p><b>Remarks</b></p> <p>(R) Front Door - Repair Traces - Yes / (R) Step - Repair Traces - Yes / Front Panel - Repair Traces - Yes / (L) Front Door - Repair Traces - Yes / (L) Rear Fender - Repair Traces - Yes / Trunk Hood, Rear Gate - Repair Traces - Yes / (R) Rear Fender - Repair Traces - Yes / (R) Rear Door - Repair Traces - Yes / (R) Center Panel - Repair Traces - Yes / Roof - Repair Traces - Yes / Overall Exterior - Full Re-Paint in same color - Yes / (R) Front Fender, Molding - Scratch - Minimal / (R) Mirror - Scratch - Small / (R) Front Door, Molding - Scratch &amp; Dent - Small / (R) Center Panel - Scratch - Minimal / (R) Rear Door, Molding - Scratch &amp; Dent - Large / (R) Step, In-panel, Side Spoiler - Scratch &amp; Dent - Medium / (R) Rear Fender, Molding - Scratch &amp; Dent - Medium / Roof - Rust, Corrosion - Small / Trunk Hood, Rear Gate - Scratch - Medium / Rear Bumper, Lamps, Panels - Crack, Gap - Large / (L) Rear Fender, Molding - Repair mark - Yes / (L) Rear Fender, Molding - Scratch &amp; Dent - Small / (L) Front Door, Molding - Scratch &amp; Dent - Minimal / (L) Mirror - Scratch - Medium / (L) Step, In-panel, Side Spoiler - Scratch - Small / (L) Front Fender, Molding - Scratch - Minimal / Front Panel - Scratch &amp; Dent - Minimal / Front Bumper, Grille, Lamps - Scratch - Medium / Front Windshield - Scratch, Stone chip - Large / (R) Rear Door, Molding - Repair mark - Yes</p> |

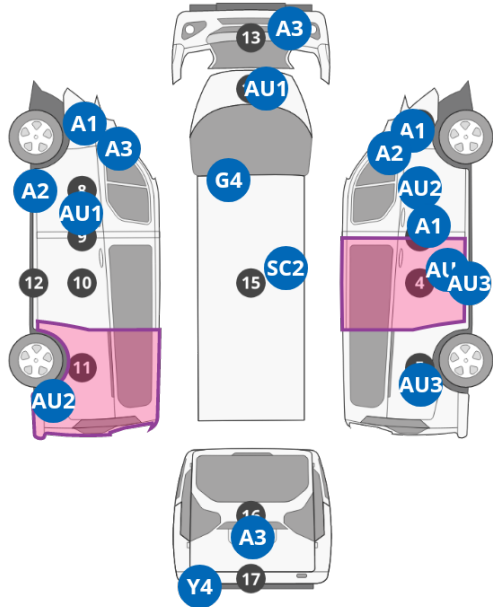
| Inspector Notes |
|---|
| With Lto plate, with spare tire, 1key, no warranty booklet, no jack and tools, scratches on headlights and taillights, aircon issue, airbag warning lamp on, |
