## General Information

| Make | Mitsubishi | Model | Mirage |

## Body / Panel Condition

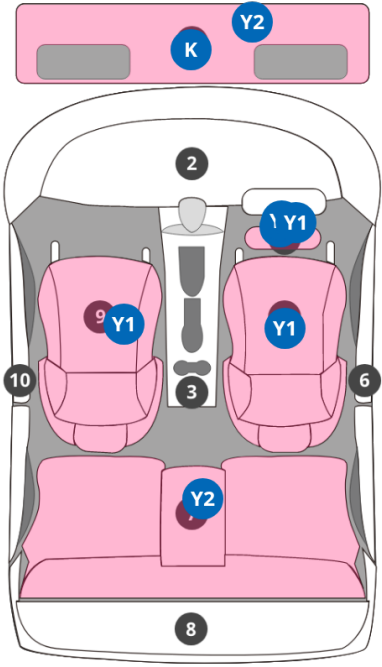
| Interior Evaluation : <b>B</b> | Exterior Evaluation : <b>E</b> |
|---|---|
| <p><b>Remarks</b></p> <p>Overall Interior - Animal Hair - Yes / Ceiling - Grime - Small / (R) Front Floor Mat - Grime - Minimal / (L) Front Floor Mat - Grime - Minimal / (R) Front Seat - Grime - Minimal / (L) Front Seat - Grime - Minimal / Rear Seat - Grime - Small / Mat Other - Grime - Minimal</p> | <p><b>Remarks</b></p> <p>(L) Front Door, Molding - Scratch - Small / (L) Rear Door, Molding - Scratch - Large / (L) Front Fender, Molding - Scratch - Medium / Front Bumper, Grille, Lamps - Scratch - Small / Bonnet, Headlight - Scratch - Minimal / (R) Front Fender, Molding - Scratch - Medium / (R) Front Door, Molding - Scratch - Large / (R) Rear Door, Molding - Scratch - Large / (R) Rear Fender, Molding - Scratch - Small / Rear Bumper, Lamps, Panels - Scratch - Medium / Trunk Hood, Rear Gate - Scratch - Small / (L) Rear Fender, Molding - Scratch - Large / (R) Side Window - Scratch, Stone chip - Small / (L) Step, In-panel, Side Spoiler - Scratch - Minimal / (R) Step, In-panel, Side Spoiler - Scratch - Minimal / (R) Mirror - Scratch - Minimal</p> |

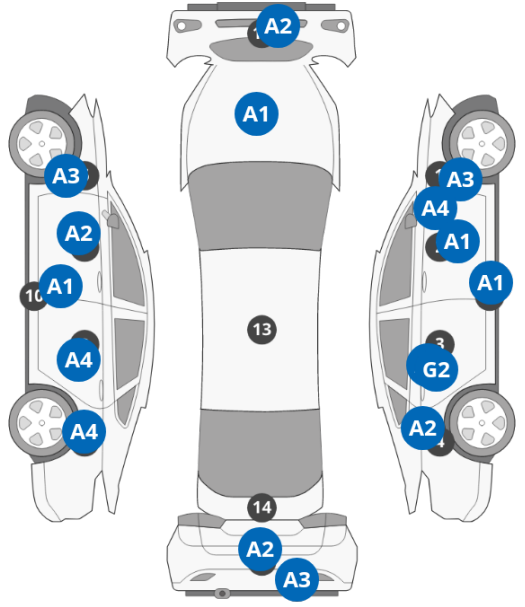
| Inspector Notes |
|---|
| Small scratch at Right rear window. Visible hairline scratches. Seatcover detached. Incomplete tools. Without warranty booklet. With jack, LTO PLate and 1key. |
