## General Information

| Make | Nissan | Model | Navara |
| YOM | 2018 | Odo Meter Reading | 65,716 |
| Registration No. | GAM8000 | Chassis No. | MNTCC4D23Z0039321 |

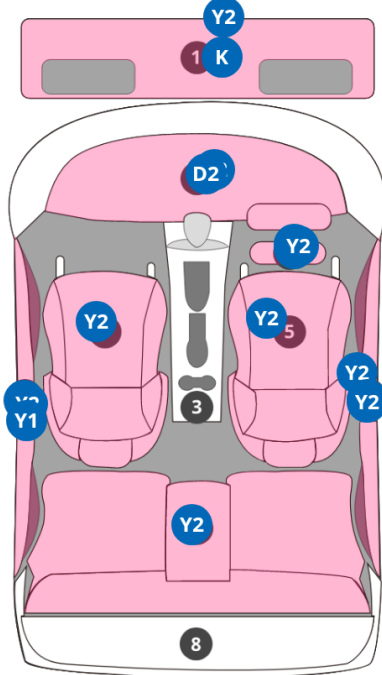
| Interior Evaluation : <span>C</span> | Exterior Evaluation : <span>E</span> |
| <b>Remarks</b><br>Ceiling - Grime - Small / Overall Interior - Animal Hair - Yes / (R) Front Floor Mat - Grime - Small / (L) Front Floor Mat - Grime - Small / Rear Seat - Grime - Small / (R) Front Seat - Grime - Small / Mat Other - Grime - Small / (R) Front Trim - Grime - Small / Trim Other - Grime - Minimal / (R) Rear Trim - Grime - Small / (L) Front Trim - Grime - Small / (L) Rear Trim - Grime - Small / Trim Other - Grime - Minimal / (L) Front Seat - Grime - Small / Steering Wheel - Worn, Peel, Crack - Small / Glove Box - Loose, Deformed - Small | <b>Remarks</b><br>Bonnet, Headlight - Scratch - Small / Front Bumper, Grille, Lamps - Scratch & Dent - Large / (R) Front Fender, Molding - Scratch - Large / Front Windshield - Scratch, Stone chip - Medium / (R) Front Door, Molding - Scratch - Small / (R) Rear Door, Molding - Scratch - Large / (R) Step, In-panel, Side Spoiler - Scratch & Dent - Large / (R) Step, In-panel, Side Spoiler - Partially Missing - Yes / (L) Step, In-panel, Side Spoiler - Partially Missing - Yes / (R) Mirror - Scratch - Minimal / (R) Guard Frame - Scratch - Large / (R) Side Gate - Scratch & Dent - Small / Rear Bumper, Lamps, Panels - Dent - Medium / Rear Gate - Scratch - Small / Roof - Modified - Large / (L) Side Gate - Scratch - Large / (L) Rear Door, Molding - Scratch & Dent - Large / (L) Step, In-panel, Side Spoiler - Scratch - Medium / (L) Mirror - Scratch - Small / (L) Guard Frame - Scratch - Large / (L) Front Door, Molding - Scratch - Large / (L) Front Fender, Molding - Scratch - Medium |

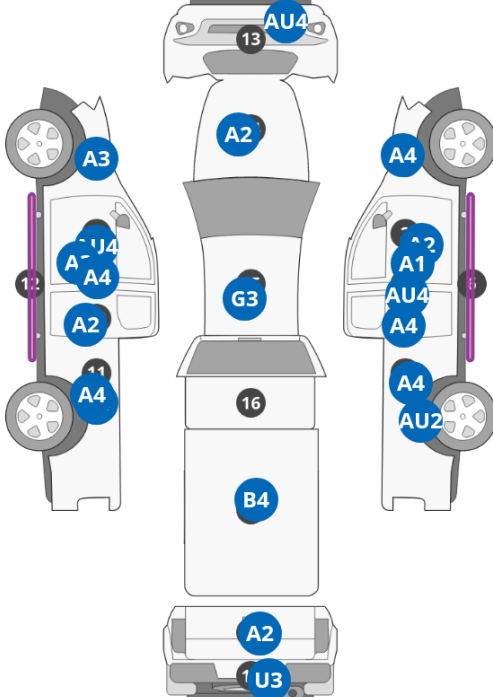
| Inspector Notes |
|---|
| Possible flooded. Scratches and gap at frontbumper. Visible hairline scratches. Repainted at right rear door. Trunk rear gate hard to open. Front hood hard to open. Left brake light busted. Crack at both sides rear lights. Incomplete tools. Without jack, Seatcover. With warranty booklet, LTO plate and 1key. |
