## General Information

| Make | Toyota | Model | Vios |
| YOM | 2022 | Odo Meter Reading | 76,655 |
| Registration No. | NFE4181 | Chassis No. | PA1B18F36N4181194 |

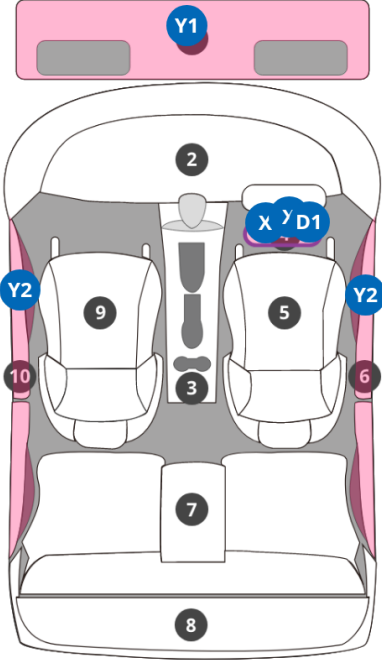
| Interior Evaluation : <b>B</b> | Exterior Evaluation : <b>D</b> |
|---|---|
| <p><b>Remarks</b><br/>Ceiling - Grime - Minimal / (R) Front Floor Mat - Missing - Yes / Mat Other - Missing - Yes / (R) Front Trim - Grime - Small / (L) Front Trim - Grime - Small / Carpet - Worked - Minimal</p> | <p><b>Remarks</b><br/>(R) Front Fender, Molding - Scratch - Minimal / (R) Mirror - Scratch - Minimal / (R) Front Door, Molding - Scratch &amp; Dent - Minimal / (R) Step, In-panel, Side Spoiler - Scratch - Minimal / (R) Rear Door, Molding - Scratch &amp; Dent - Minimal / (R) Rear Fender, Molding - Scratch - Small / Rear Bumper, Lamps, Panels - Scratch &amp; Dent - Small / Trunk Hood, Rear Gate - Scratch - Minimal / (L) Rear Fender, Molding - Scratch - Minimal / (L) Rear Door, Molding - Scratch &amp; Dent - Small / (L) Front Door, Molding - Scratch &amp; Dent - Large / (L) Step, In-panel, Side Spoiler - Scratch - Minimal / (L) Mirror - Crack - Damaged / (L) Front Fender, Molding - Scratch - Minimal / Front Bumper, Grille, Lamps - Scratch - Minimal / (L) Mirror - Scratch - Minimal / Bonnet, Headlight - Scratch - Minimal / (R) Front Tyre - Crack, Cut - Yes</p> |

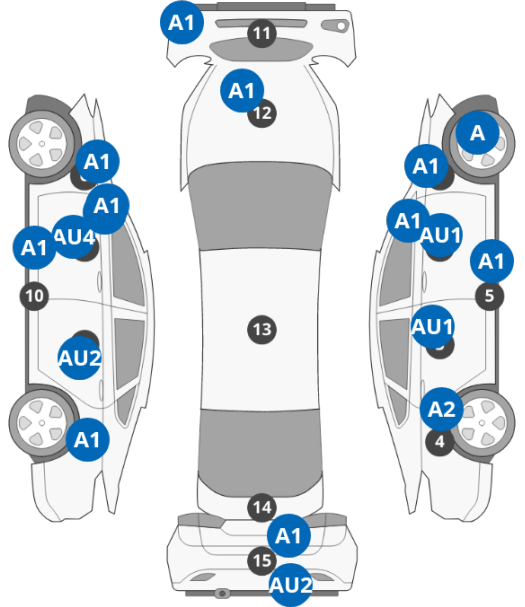
| Inspector Notes |
|---|
| With Lto plate, with spare tire and jack, with warranty booklet, 2keys, no tools, scratches on headlights and taillights, |
