## General Information

| Make | Toyota | Model | Vios |

## Body / Panel Condition

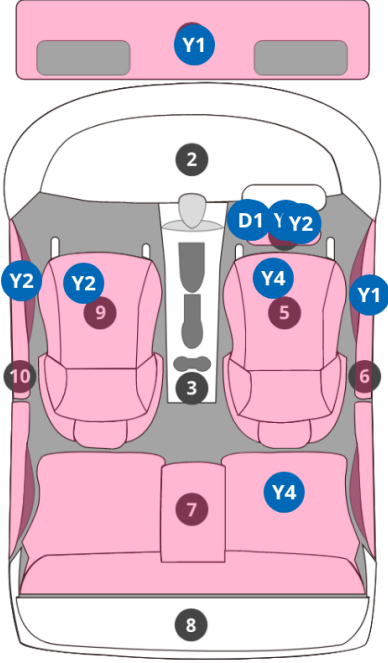
| Interior Evaluation : <b>C</b> | Exterior Evaluation : <b>E</b> |
| <p><b>Remarks</b></p> <p>Ceiling - Grime - Minimal / Rear Seat - Grime - Large / Mat Other - Grime - Small / (R) Front Trim - Grime - Minimal / (R) Front Seat - Grime - Large / (R) Front Floor Mat - Grime - Small / (L) Front Trim - Grime - Small / (L) Front Seat - Grime - Small / (L) Front Floor Mat - Cut, Crack - Small / Carpet - Worked - Minimal</p> | <p><b>Remarks</b></p> <p>(R) Front Fender, Molding - Scratch &amp; Dent - Large / (R) Mirror - Scratch - Minimal / (R) Rear Door, Molding - Scratch - Large / (R) Front Door, Molding - Scratch - Large / (R) Rear Fender, Molding - Scratch &amp; Dent - Small / Roof - Scratch - Minimal / Rear Bumper, Lamps, Panels - Scratch &amp; Dent - Small / Trunk Hood, Rear Gate - Scratch &amp; Dent - Minimal / (L) Rear Fender, Molding - Scratch &amp; Dent - Large / (L) Rear Door, Molding - Scratch &amp; Dent - Medium / (L) Step, In-panel, Side Spoiler - Scratch &amp; Dent - Minimal / (L) Mirror - Scratch - Small / (L) Front Door, Molding - Scratch - Small / (L) Front Fender, Molding - Scratch - Minimal / Front Bumper, Grille, Lamps - Scratch - Large / (R) Step, In-panel, Side Spoiler - Scratch &amp; Dent - Small / Bonnet, Headlight - Scratch - Minimal</p> |

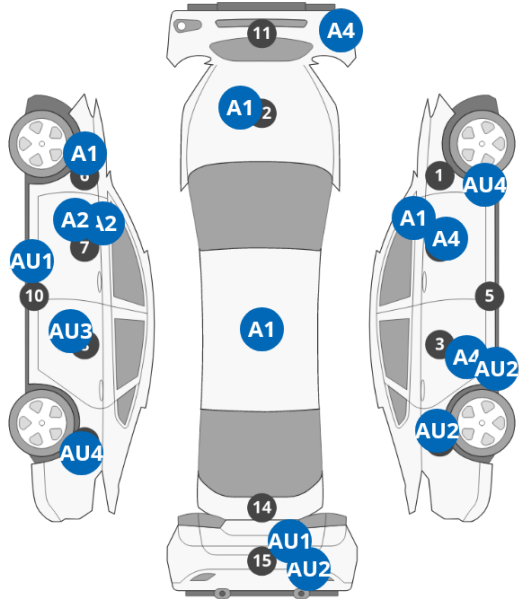
| Inspector Notes |
|---|
| With Lto plate, with spare tire, 1key, no warranty booklet, no jack and tools, scratches on headlights and taillights, |
