## General Information

| Make | Toyota | Model | Vios |
| Registration No. | EAE2145 | Chassis No. | PA1B18F32M4140060 |

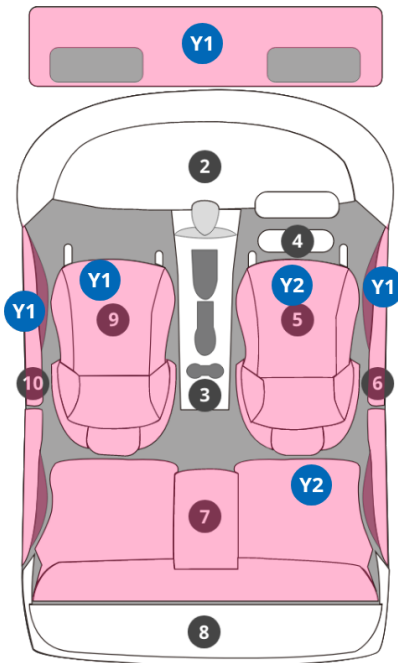
| Interior Evaluation : <b>A</b> | Exterior Evaluation : <b>D</b> |
|---|---|
| <p><b>Remarks</b></p> <p>Ceiling - Grime - Minimal / Rear Seat - Grime - Small / (R) Front Seat - Grime - Small / (R) Front Trim - Grime - Minimal / (L) Front Trim - Grime - Minimal / (L) Front Seat - Grime - Minimal</p> | <p><b>Remarks</b></p> <p>Bonnet - Repair Traces - Yes / (L) Rear Door - Repair Traces - Yes / (L) Rear Fender - Repair Traces - Yes / Trunk Hood, Rear Gate - Repair Traces - Yes / (R) Rear Fender - Repair Traces - Yes / (R) Rear Door - Repair Traces - Yes / Roof - Repair Traces - Yes / (R) Front Fender, Molding - Scratch - Minimal / (R) Mirror - Scratch - Minimal / (R) Front Door, Molding - Scratch - Minimal / (R) Step, In-panel, Side Spoiler - Scratch &amp; Dent - Small / (R) Rear Door, Molding - Repair mark - Yes / (R) Rear Door, Molding - Scratch - Minimal / (R) Rear Fender, Molding - Repair mark - Yes / (R) Rear Fender, Molding - Scratch - Minimal / Trunk Hood, Rear Gate - Scratch - Minimal / Rear Bumper, Lamps, Panels - Scratch - Minimal / (L) Rear Fender, Molding - Scratch - Minimal / (L) Rear Door, Molding - Scratch - Minimal / (L) Front Door, Molding - Scratch &amp; Dent - Minimal / (L) Step, In-panel, Side Spoiler - Scratch &amp; Dent - Large / (L) Front Fender, Molding - Scratch &amp; Dent - Small / Member (Bolted) - Dent - Yes / Front Bumper, Grille, Lamps - Scratch - Minimal / Bonnet, Headlight - Repair mark - Difference in Color / Bonnet, Headlight - Scratch - Minimal / Front Windshield - Damaged - Large / Overall Exterior - Full Re-Paint in same color - Yes</p> |

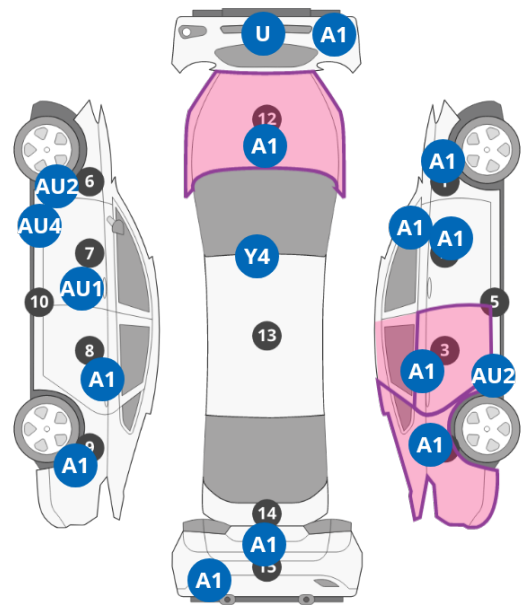
| Inspector Notes |
|---|
| With Lto plate, with spare tire and jack, 1key, no warranty booklet and tools, scratches on headlights and taillights |
