## General Information

| Make | Toyota | Model | Vios |
| Registration No. | DBP6050 | Chassis No. | PA1B18F3XR4264391 |

## Body / Panel Condition

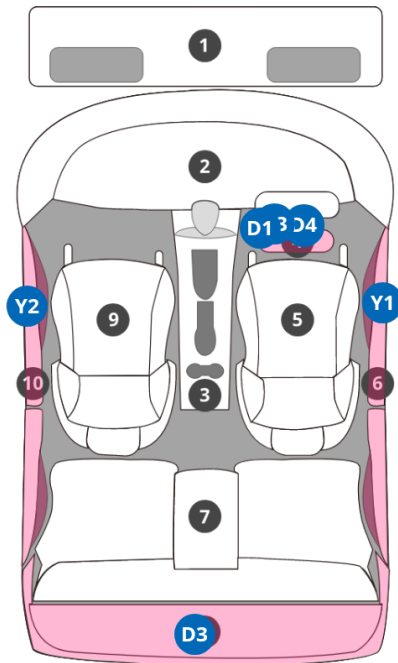
| Interior Evaluation : <span style="color: red;">C</span> | Exterior Evaluation : <span style="color: red;">C</span> |
| <p><b>Remarks</b><br/>Mat Other - Grime - Medium / Trunk Room - Loose, Deformed - Medium / (R) Front Trim - Grime - Minimal / (R) Front Floor Mat - Worked - Large / (L) Front Trim - Grime - Small / (L) Front Floor Mat - Cut, Crack - Medium / Carpet - Worked - Minimal</p> | <p><b>Remarks</b><br/>Bonnet - Repair Traces - Yes / (R) Front Fender, Molding - Scratch &amp; Dent - Large / (R) Front Door, Molding - Scratch - Minimal / (R) Step, In-panel, Side Spoiler - Scratch - Minimal / (R) Rear Door, Molding - Scratch - Minimal / (R) Rear Fender, Molding - Scratch - Minimal / Rear Bumper, Lamps, Panels - Scratch - Minimal / Trunk Hood, Rear Gate - Scratch &amp; Dent - Small / (L) Rear Fender, Molding - Scratch &amp; Dent - Minimal / (L) Rear Door, Molding - Scratch &amp; Dent - Minimal / Roof - Scratch &amp; Dent - Minimal / (L) Front Door, Molding - Scratch - Minimal / (L) Mirror - Scratch - Minimal / (L) Step, In-panel, Side Spoiler - Scratch - Minimal / (L) Front Fender, Molding - Scratch - Minimal / Front Bumper, Grille, Lamps - Scratch &amp; Dent - Large / Bonnet, Headlight - Scratch &amp; Dent - Small</p> |
