## General Information

| Make | Toyota | Model | Vios |
| Registration No. | NJA2962 | Chassis No. | PA1B18F3XR4280879 |

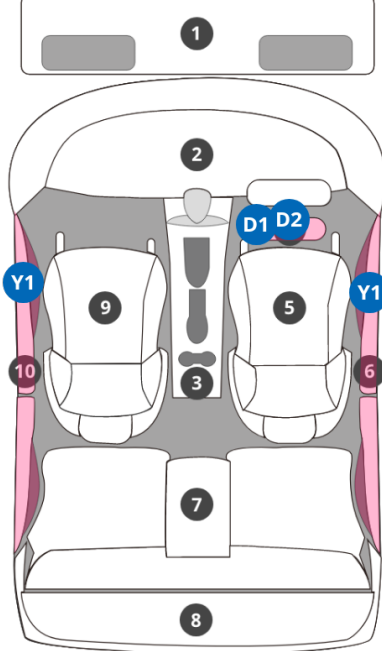
| Interior Evaluation : <b>A</b> | Exterior Evaluation : <b>B</b> |
|---|---|
| <p><b>Remarks</b><br/>(R) Front Trim - Grime - Minimal / (L) Front Trim - Grime - Minimal / (L) Front Floor Mat - Worked - Small / Carpet - Worked - Minimal</p> | <p><b>Remarks</b><br/>(R) Front Door - Repair Traces - Yes / (R) Front Fender - Repair Traces - Yes / Bonnet - Repair Traces - Yes / (L) Front Door - Repair Traces - Yes / (L) Rear Door - Repair Traces - Yes / (L) Rear Fender - Repair Traces - Yes / Trunk Hood, Rear Gate - Repair Traces - Yes / (R) Rear Fender - Repair Traces - Yes / (R) Rear Door - Repair Traces - Yes / Roof - Repair Traces - Yes / (R) Mirror - Scratch - Minimal / (R) Front Door, Molding - Scratch - Minimal / (R) Rear Door, Molding - Scratch - Minimal / Roof - Scratch - Minimal / (R) Rear Fender, Molding - Scratch &amp; Dent - Minimal / Trunk Hood, Rear Gate - Scratch - Minimal / Rear Bumper, Lamps, Panels - Scratch - Minimal / (L) Rear Fender, Molding - Scratch - Minimal / (L) Rear Door, Molding - Scratch - Minimal / (L) Front Door, Molding - Scratch - Minimal / (L) Step, In-panel, Side Spoiler - Scratch - Minimal / (L) Front Fender, Molding - Dent - Minimal / Front Bumper, Grille, Lamps - Scratch - Minimal / Bonnet, Headlight - Scratch - Minimal / Overall Exterior - Full Re-Paint in same color - Yes</p> |

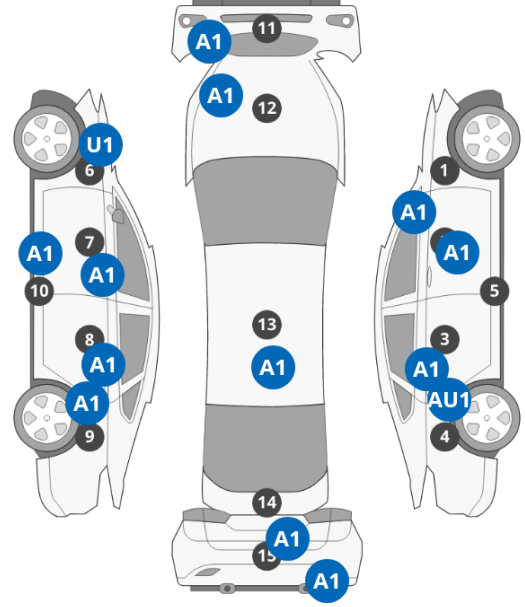
| Inspector Notes |
|---|
| With Lto plate, with jack, 1key, no warranty booklet, no spare tire and tools, scratches on headlights, sun cracks taillights |
