## General Information

| Make | Suzuki | Model | S-Presso |
| Registration No. | NKQ3563 | Chassis No. | MA3FL61S4TA538779 |

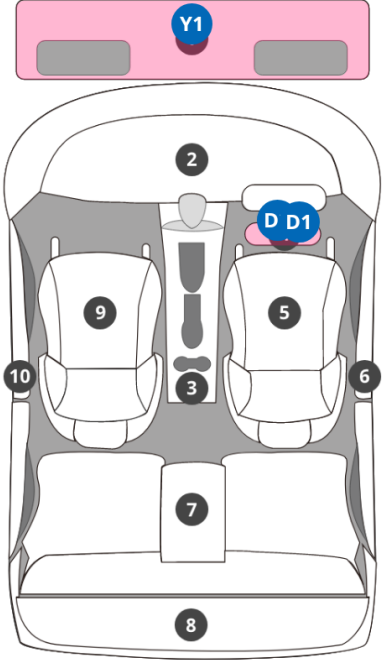
| Interior Evaluation : <b>A</b> | Exterior Evaluation : <b>B</b> |
|---|---|
| <b>Remarks</b><br>Ceiling - Grime - Minimal / (L) Front Floor Mat - Worked - Small / Carpet - Worked - Minimal | <b>Remarks</b><br>(R) Front Fender, Molding - Scratch - Minimal / (R) Mirror - Scratch - Minimal / (R) Front Door, Molding - Scratch - Minimal / (R) Step, In-panel, Side Spoiler - Scratch - Minimal / (R) Rear Door, Molding - Scratch - Minimal / Roof - Scratch & Dent - Medium / (R) Rear Fender, Molding - Scratch - Minimal / Rear Bumper, Lamps, Panels - Scratch - Minimal / Trunk Hood, Rear Gate - Scratch - Minimal / (L) Rear Fender, Molding - Scratch - Minimal / (L) Rear Door, Molding - Scratch - Minimal / (L) Front Door, Molding - Scratch - Minimal / (L) Step, In-panel, Side Spoiler - Scratch - Minimal / (L) Mirror - Scratch - Minimal / (L) Front Fender, Molding - Scratch & Dent - Small / Front Bumper, Grille, Lamps - Scratch & Dent - Small / Bonnet, Headlight - Scratch - Minimal |

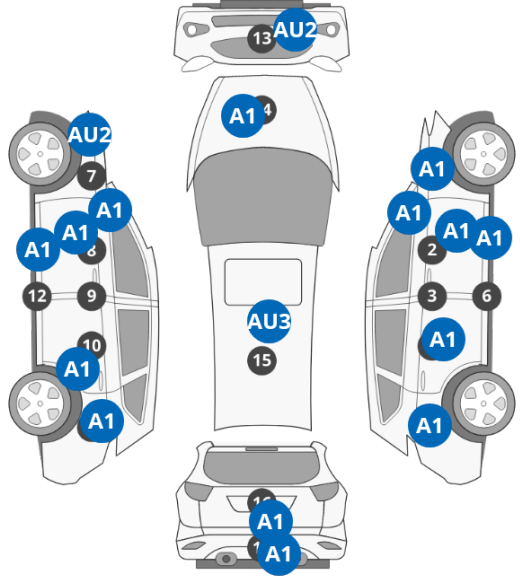
| Inspector Notes |
|---|
| With Lto plate, with spare tire and jack, with warranty booklet, 3keys, no tools, scratches on headlights, unlock remote when starting |
