## General Information

| Make | Toyota | Model | Vios |

## Body / Panel Condition

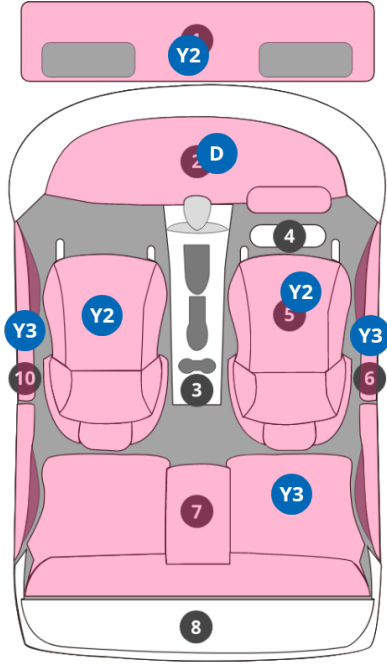
| Interior Evaluation : <span>C</span> | Exterior Evaluation : <span>C</span> |
|---|---|
| <b>Remarks</b><br>(R) Front Trim - Grime - Medium / (L) Front Trim - Grime - Medium / Dashboard - Traces of Adhesive Tape - Yes / Ceiling - Grime - Small / Rear Seat - Grime - Medium / (R) Front Seat - Grime - Small / (L) Front Seat - Grime - Small | <b>Remarks</b><br>(R) Step - Repair Traces - Yes / Bonnet - Repair Traces - Yes / Roof - Repair Traces - Yes / Trunk Hood, Rear Gate - Modified - Medium / (L) Rear Door, Molding - Scratch & Dent - Medium / (L) Front Door, Molding - Scratch - Small / (R) Front Door, Molding - Dent - Small / (R) Rear Door, Molding - Modified - Small / Front Bumper, Grille, Lamps - Modified - Medium / Bonnet, Headlight - Scratch - Small / (L) Rear Fender, Molding - Scratch - Small |

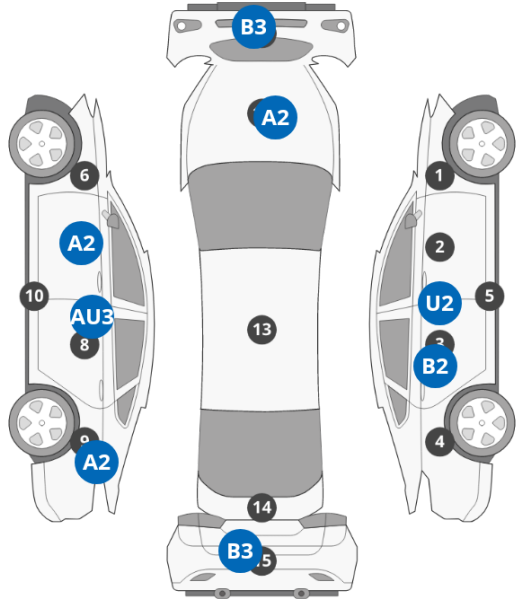
Modified muffler, Missing headlight, park light, and signal light in front. Repainted hood and roof, no spare tire. no spare key, with seat cover, no warranty booklet. no jack and tools
