## General Information

| Make | Suzuki | Model | S-Presso |
| YOM | 2026 | Odo Meter Reading | 25,155 |
| Registration No. | FAT8304 | Chassis No. | MA3FL61S4TA554903 |

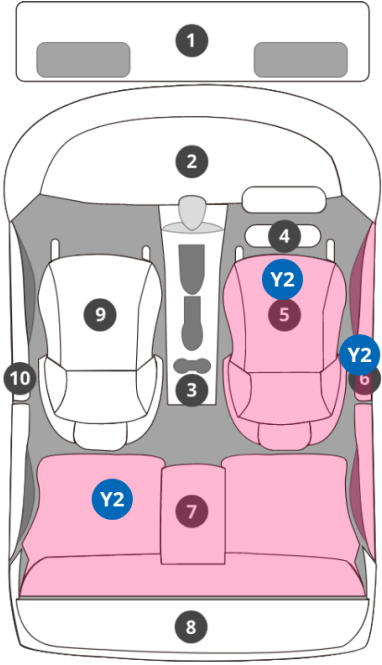
| Interior Evaluation : <span style="color: red; font-weight: bold;">A</span> | Exterior Evaluation : <span style="color: red; font-weight: bold;">B</span> |
| <b>Remarks</b><br>(R) Front Seat - Grime - Small / (R) Front Trim - Grime - Small / Rear Seat - Grime - Small | <b>Remarks</b><br>(R) Rear Door, Molding - Dent - Medium / (R) Front Fender, Molding - Scratch - Small / (L) Front Door, Molding - Scratch - Small / (L) Rear Door, Molding - Scratch - Small / (L) Front Fender, Molding - Scratch - Medium / (R) Front Door, Molding - Scratch - Small |
