## General Information

| Make | Mitsubishi | Model | Mirage |
| YOM | 2026 | Odo Meter Reading | 5,533 |
| Registration No. | NKT9034 | Chassis No. | PAEA13RJTSA012163 |

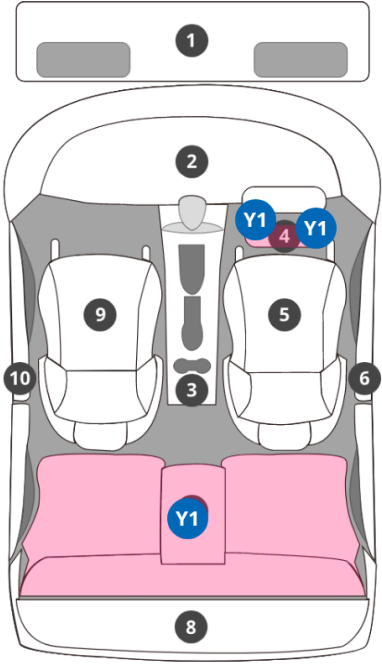
| Interior Evaluation : <span style="color: red; font-weight: bold;">A</span> | Exterior Evaluation : <span style="color: red; font-weight: bold;">B</span> |
| <b>Remarks</b><br>Rear Seat - Grime - Minimal / (R) Front Floor Mat - Grime - Minimal / (L) Front Floor Mat - Grime - Minimal | <b>Remarks</b><br>(L) Front Fender, Molding - Scratch - Minimal / (L) Front Door, Molding - Scratch - Minimal / (L) Step, In-panel, Side Spoiler - Scratch - Small / (L) Rear Door, Molding - Scratch - Minimal / (L) Rear Fender, Molding - Scratch - Minimal / Rear Bumper, Lamps, Panels - Scratch - Minimal / Trunk Hood, Rear Gate - Scratch - Minimal / (R) Rear Fender, Molding - Scratch - Minimal / (R) Rear Door, Molding - Scratch - Small / (R) Step, In-panel, Side Spoiler - Scratch - Minimal / (R) Front Door, Molding - Scratch - Small / (R) Front Fender, Molding - Scratch - Small / Front Bumper, Grille, Lamps - Scratch - Minimal / Bonnet, Headlight - Scratch - Small / Roof - Scratch - Small |

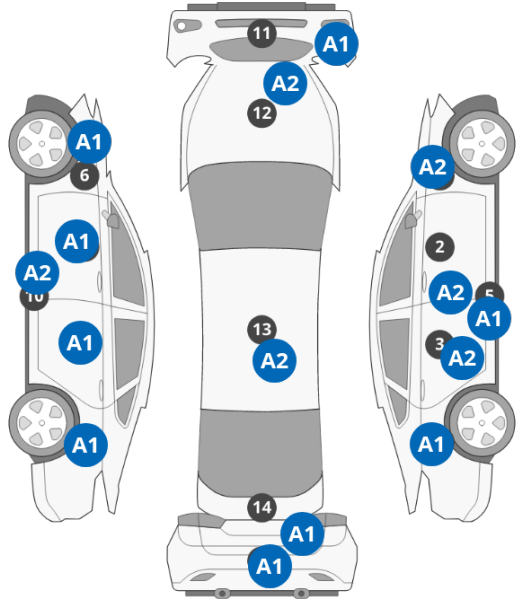
no LTO plate/no warranty booklet/no tools with jack/with spare tire/hairline scratches on the body/maintenance warning lamp on
