## General Information

| Make | Suzuki | Model | Carry |
| YOM | 2025 | Odo Meter Reading | 4,019 |
| Registration No. | MBD7205 | Chassis No. | MHYDC61T4SJ270605 |

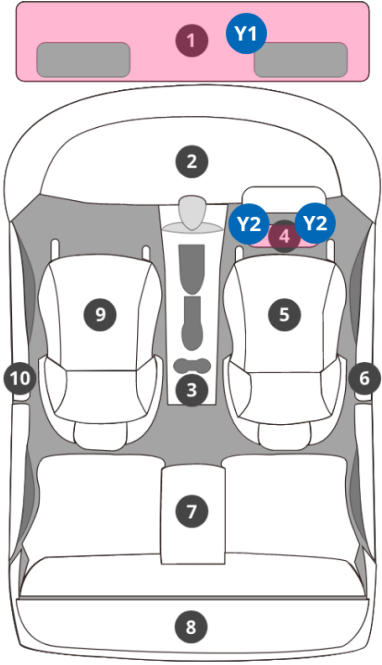
| Interior Evaluation : <span style="color: red; font-weight: bold;">A</span> | Exterior Evaluation : <span style="color: red; font-weight: bold;">C</span> |
| <b>Remarks</b><br>(R) Front Floor Mat - Grime - Small / (L) Front Floor Mat - Grime - Small / Ceiling - Grime - Minimal | <b>Remarks</b><br>(L) Front Fender, Molding - Scratch - Minimal / (L) Front Door, Molding - Scratch - Small / (L) Step, In-panel, Side Spoiler - Scratch - Minimal / (L) Side Gate - Scratch - Small / Rear Bumper, Lamps, Panels - Scratch - Small / Rear Gate - Scratch - Minimal / Cargo Bed Floor - Scratch - Large / (R) Side Gate - Scratch - Large / (R) Front Door, Molding - Scratch - Small / (R) Mirror - Scratch - Small / (R) Step, In-panel, Side Spoiler - Scratch - Minimal / (R) Front Fender, Molding - Scratch - Minimal / Front Bumper, Grille, Lamps - Scratch - Small / Front Panel - Scratch - Minimal / Roof - Scratch - Minimal |

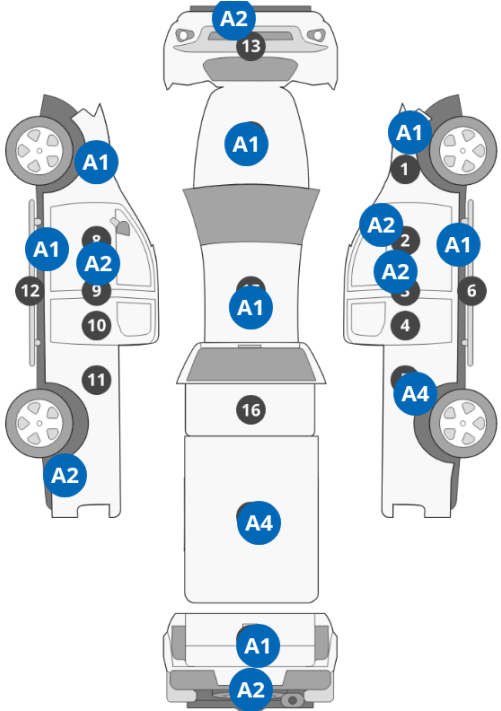
with LTO plate/with warranty booklet/incomplete tools and jack/with spare tire/hairline scratches on the body
