## General Information

| Make | MG | Model | HS |
| Registration No. | NID7292 | Chassis No. | LSJA24U97NN061823 |

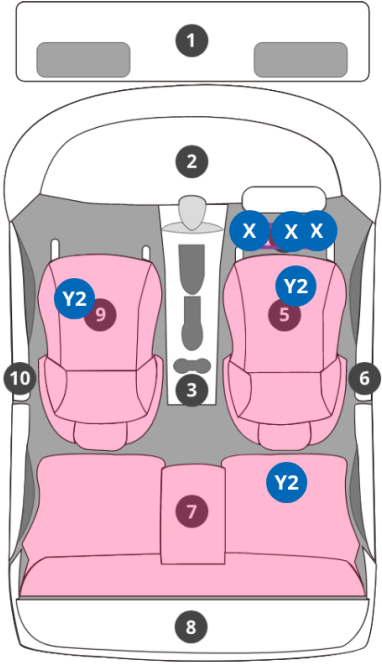
| Interior Evaluation : <b>B</b> | Exterior Evaluation : <b>D</b> |
|---|---|
| <b>Remarks</b><br>(L) Front Seat - Grime - Small / (R) Front Seat - Grime - Small / (R) Front Floor Mat - Missing - Yes / (L) Front Floor Mat - Missing - Yes / Mat Other - Missing - Yes / Rear Seat - Grime - Small | <b>Remarks</b><br>(R) Front Door, Molding - Scratch - Small / (R) Rear Door, Molding - Scratch & Dent - Medium / Rear Bumper, Lamps, Panels - Scratch & Dent - Medium / (L) Rear Fender, Molding - Scratch - Small / (L) Rear Door, Molding - Scratch - Large / (L) Front Door, Molding - Scratch - Small / (L) Front Fender, Molding - Crack, Gap - Medium / Front Bumper, Grille, Lamps - Crack, Gap - Medium / (R) Front Fender, Molding - Scratch & Dent - Small / (R) Rear Fender, Molding - Scratch - Small / Trunk Hood, Rear Gate - Scratch - Minimal / Rear Bumper, Lamps, Panels - Repair mark - Yes |

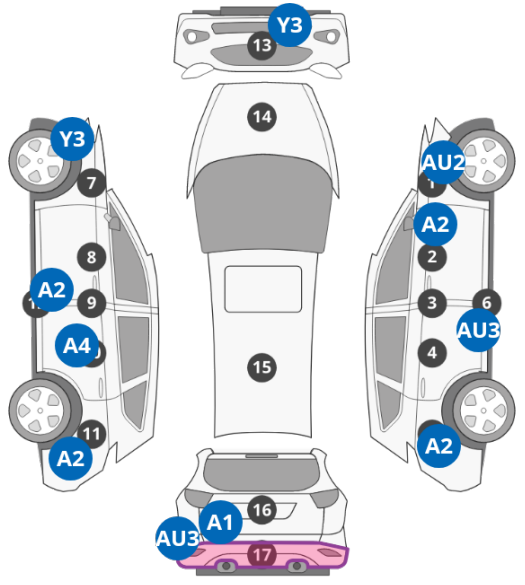
Battery for replacement. Crack left taillight. With warranty booklet and spare tire. Without jack and tools. 2 keys. With LTO plate.
