## General Information

| Make | Toyota | Model | Vios |

## Body / Panel Condition

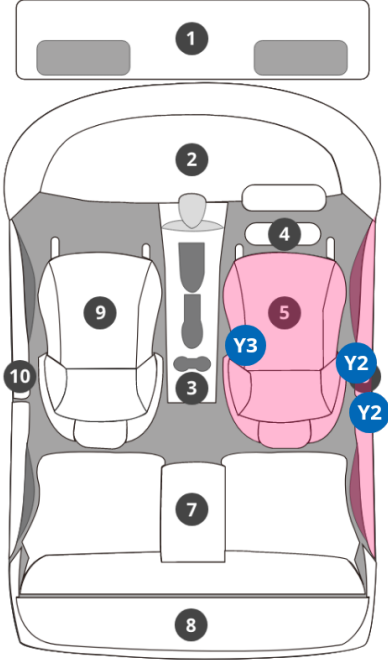
| Interior Evaluation : <b>B</b> | Exterior Evaluation : <b>C</b> |
|---|---|
| <b>Remarks</b><br>(R) Rear Trim - Grime - Small / (R) Front Trim - Grime - Small / (R) Front Seat - Grime - Medium | <b>Remarks</b><br>(R) Front Door - Repair Traces - Yes / (R) Front Fender - Repair Traces - Yes / Bonnet - Repair Traces - Yes / (L) Front Fender - Repair Traces - Yes / (L) Front Door - Repair Traces - Yes / (L) Rear Door - Repair Traces - Yes / (L) Rear Fender - Repair Traces - Yes / Trunk Hood, Rear Gate - Repair Traces - Yes / (R) Rear Fender - Repair Traces - Yes / (R) Rear Door - Repair Traces - Yes / Roof - Repair Traces - Yes / (R) Front Fender, Molding - Scratch - Small / (R) Rear Door, Molding - Scratch - Medium / Rear Bumper, Lamps, Panels - Scratch - Medium / Trunk Hood, Rear Gate - Scratch & Dent - Small / (L) Rear Door, Molding - Scratch & Dent - Small / (L) Mirror - Scratch - Minimal / Front Bumper, Grille, Lamps - Scratch & Dent - Medium / (L) Front Door, Molding - Crack, Gap - Medium / Bonnet, Headlight - Scratch - Minimal / Roof - Scratch - Small |
