## General Information

| Make | Toyota | Model | Vios |
| Registration No. | NJF1924 | Chassis No. | PA1B18F39R4277066 |

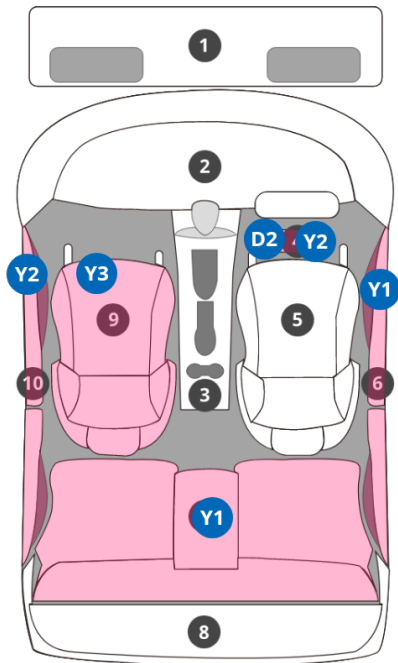
| Interior Evaluation : <b>B</b> | Exterior Evaluation : <b>E</b> |
| <b>Remarks</b><br>(R) Front Floor Mat - Grime - Small / (R) Front Trim - Grime - Minimal / Rear Seat - Grime - Minimal / (L) Front Trim - Grime - Small / (L) Front Seat - Grime - Medium / (L) Front Floor Mat - Worked - Small | <b>Remarks</b><br>(R) Front Fender, Molding - Scratch - Small / (R) Mirror - Scratch - Minimal / (R) Front Door, Molding - Scratch & Dent - Medium / (R) Step, In-panel, Side Spoiler - Scratch - Small / (R) Rear Door, Molding - Scratch - Small / (R) Rear Fender, Molding - Scratch & Dent - Small / Rear Bumper, Lamps, Panels - Scratch - Small / Trunk Hood, Rear Gate - Scratch - Small / (L) Rear Fender, Molding - Scratch - Small / (L) Step, In-panel, Side Spoiler - Scratch - Small / (L) Rear Door, Molding - Scratch - Small / (L) Mirror - Scratch - Minimal / (L) Front Door, Molding - Scratch - Small / (L) Front Fender, Molding - Scratch - Small / Front Bumper, Grille, Lamps - Scratch - Large / Bonnet, Headlight - Scratch - Small / Roof - Scratch & Dent - Small |
