## General Information

| Make | Mitsubishi | Model | Mirage |
| Registration No. | NJQ3469 | Chassis No. | PAEA13MJSSA000870 |

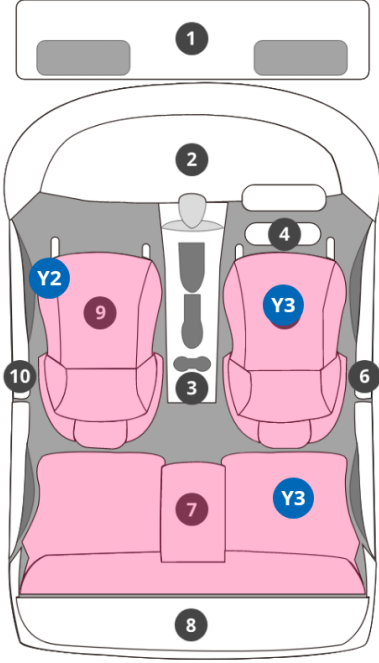
| Interior Evaluation : <b>B</b> | Exterior Evaluation : <b>B</b> |
| <b>Remarks</b><br>(R) Front Seat - Grime - Medium / Rear Seat - Grime - Medium / (L) Front Seat - Grime - Small | <b>Remarks</b><br>(R) Mirror - Scratch - Small / (R) Rear Door, Molding - Scratch - Minimal / (R) Front Door, Molding - Scratch - Minimal / (R) Rear Fender, Molding - Scratch - Minimal / Trunk Hood, Rear Gate - Scratch - Small / Rear Bumper, Lamps, Panels - Scratch - Minimal / (L) Rear Fender, Molding - Scratch - Small / (L) Rear Door, Molding - Scratch - Small / (L) Front Door, Molding - Scratch - Minimal / Bonnet, Headlight - Scratch - Small / Front Bumper, Grille, Lamps - Scratch - Small |
