## General Information

| Make | MG | Model | G50 |
| Registration No. | FAS7374 | Chassis No. | LSKK4BC10RD057201 |

## Body / Panel Condition

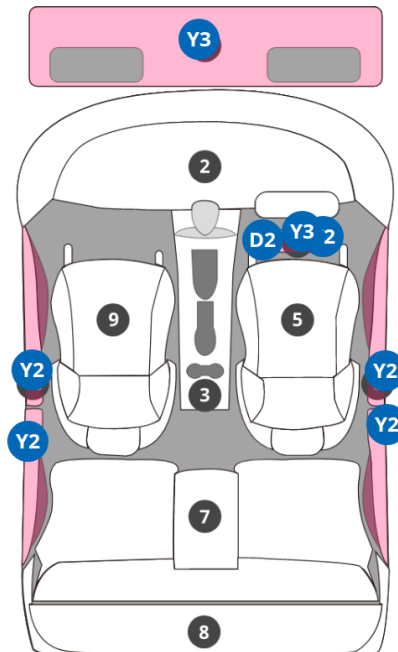
| Interior Evaluation : <span style="color: red; font-weight: bold;">C</span> | Exterior Evaluation : <span style="color: red; font-weight: bold;">E</span> |
|---|---|
| <b>Remarks</b><br>Ceiling - Grime - Medium / (R) Front Trim - Grime - Small / (R) Front Floor Mat - Grime - Small / Trim Other - Grime - Small / (L) Rear Trim - Grime - Small / Mat Other - Grime - Medium / (L) Front Trim - Grime - Small / (L) Front Floor Mat - Worked - Small | <b>Remarks</b><br>(L) Front Door, Molding - Scratch & Dent - Large / (L) Rear Door, Molding - Scratch & Dent - Medium / (L) Rear Fender, Molding - Scratch - Small / Trunk Hood, Rear Gate - Scratch - Small / Rear Bumper, Lamps, Panels - Scratch - Medium / (R) Rear Fender, Molding - Scratch - Medium / (R) Rear Door, Molding - Scratch - Minimal / (R) Front Door, Molding - Scratch - Large / (R) Front Fender, Molding - Scratch & Dent - Minimal / Bonnet, Headlight - Scratch & Dent - Minimal / Front Bumper, Grille, Lamps - Scratch & Dent - Medium / (L) Mirror - Scratch - Minimal / (L) Front Fender, Molding - Scratch - Medium |

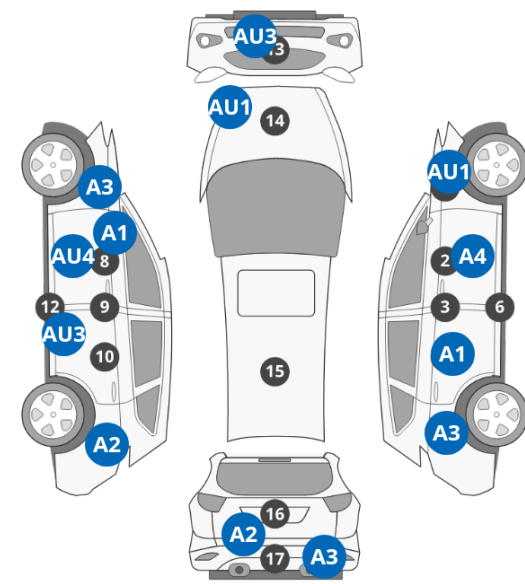
Gap at left front door and bonnet. With warranty booklet, spare tire, jack and seat cover. Without tools. 1 key. With LTO plate.
