## General Information

| Make | Mitsubishi | Model | L300 |
| Registration No. | NKT6126 | Chassis No. | PAEL65NYTSB007595 |

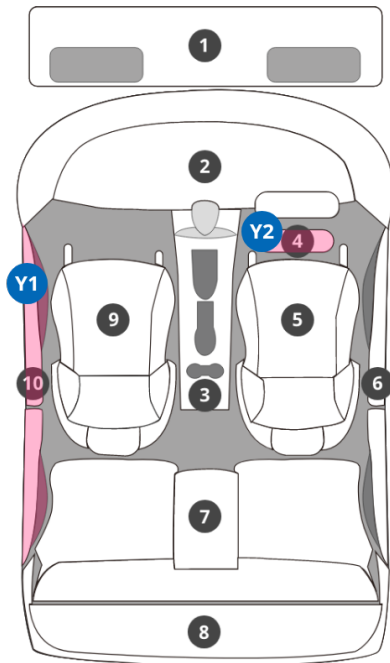
| Interior Evaluation : <span style="color: red;">A</span> | Exterior Evaluation : <span style="color: red;">C</span> |
| <b>Remarks</b><br>(L) Front Floor Mat - Grime - Small / (L) Front Trim - Grime - Minimal | <b>Remarks</b><br>(L) Center Panel - Scratch & Dent - Medium / (L) Front Fender, Molding - Scratch - Minimal / (L) Front Door, Molding - Scratch - Small / (L) Step, In-panel, Side Spoiler - Scratch - Small / (L) Side Gate - Scratch - Small / Rear Bumper, Lamps, Panels - Rust, Corrosion - Small / Rear Gate - Scratch - Small / Cargo Bed Floor - Scratch - Small / (R) Side Gate - Scratch - Small / (R) Front Door, Molding - Scratch - Small / (R) Front Fender, Molding - Scratch - Minimal / (R) Step, In-panel, Side Spoiler - Scratch - Small / Front Bumper, Grille, Lamps - Scratch - Small / Front Panel - Scratch - Minimal / Roof - Scratch - Minimal |
