## General Information

| Make | Toyota | Model | Vios |

## Body / Panel Condition

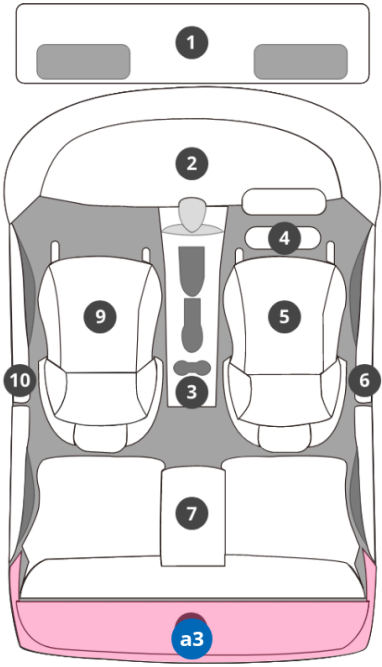
| <b>Remarks</b><br>Trunk Room - Worn, Scratch, Cut, Crack - Medium | <b>Remarks</b><br>Rear Bumper, Lamps, Panels - Scratch & Dent - Small / Trunk Hood, Rear Gate - Dent - Medium / (R) Rear Door, Molding - Scratch & Dent - Minimal / Front Bumper, Grille, Lamps - Scratch - Medium |

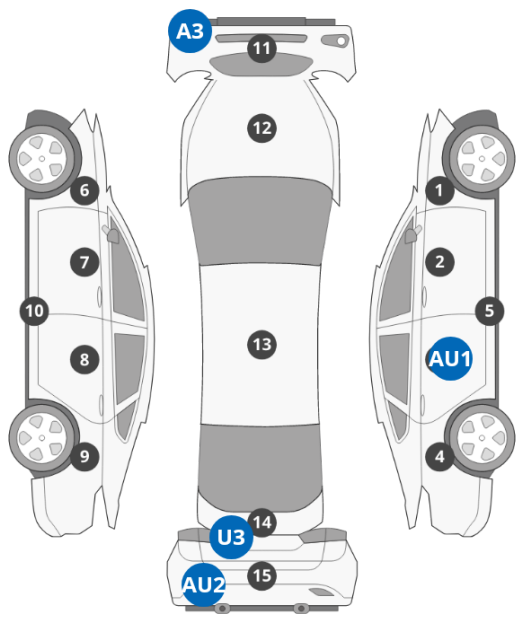
| has hairline scratchers/ no reverse camera/ tires needs to be inflated to spec |
