## General Information

| Make | Toyota | Model | Raize |
| YOM | 2025 | Odo Meter Reading | 14,913 |
| Registration No. | DBR2338 | Chassis No. | MHKAB1BA0RJ099376 |

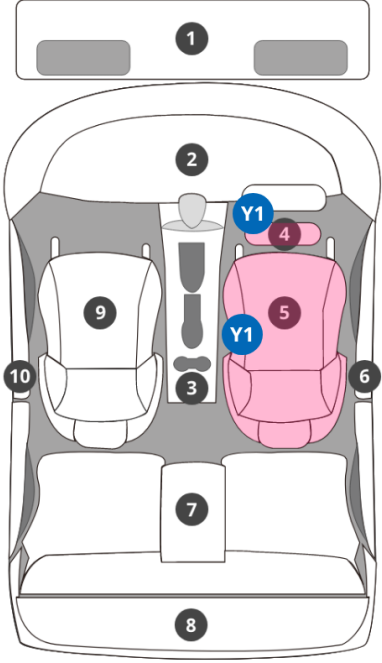
| Interior Evaluation : <span style="color: red; font-weight: bold;">A</span> | Exterior Evaluation : <span style="color: red; font-weight: bold;">C</span> |
| <b>Remarks</b><br>(R) Front Seat - Grime - Minimal / (L) Front Floor Mat - Grime - Minimal | <b>Remarks</b><br>(L) Front Fender, Molding - Scratch - Small / (L) Mirror - Scratch - Minimal / (L) Step, In-panel, Side Spoiler - Scratch - Small / (L) Front Door, Molding - Scratch - Minimal / (L) Rear Door, Molding - Scratch - Minimal / (L) Rear Fender, Molding - Scratch - Minimal / Rear Bumper, Lamps, Panels - Scratch - Small / Trunk Hood, Rear Gate - Scratch - Small / (R) Rear Fender, Molding - Scratch - Minimal / (R) Step, In-panel, Side Spoiler - Scratch - Small / (R) Rear Door, Molding - Scratch & Dent - Minimal / (R) Front Door, Molding - Scratch - Minimal / (R) Front Fender, Molding - Scratch - Minimal / Front Bumper, Grille, Lamps - Scratch - Small / Bonnet, Headlight - Scratch - Minimal / Roof - Scratch - Medium |
