## General Information

| Make | Toyota | Model | Wigo |
| Registration No. | NGC3195 | Chassis No. | MHKA4DE5FNJ017672 |

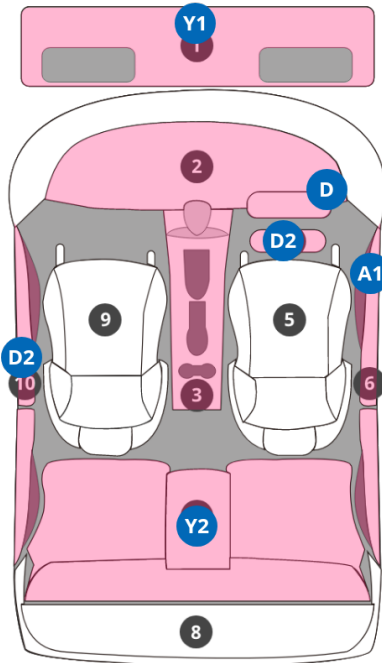
| Interior Evaluation : <b>B</b> | Exterior Evaluation : <b>C</b> |
|---|---|
| <b>Remarks</b><br>(R) Front Trim - Cut, Crack - Minimal / Rear Seat - Grime - Small / Dashboard - Repair Mark - Yes / (L) Front Floor Mat - Worked - Small / (L) Front Trim - Worked - Small / Ceiling - Grime - Minimal / Room Mirror - Missing - Yes | <b>Remarks</b><br>(R) Front Door - Repair Traces - Yes / (R) Step - Repair Traces - Yes / (R) Front Fender - Repair Traces - Yes / Bonnet - Repair Traces - Yes / (R) Rear Door, Molding - Scratch & Dent - Small / (R) Rear Fender, Molding - Scratch & Dent - Medium / Rear Bumper, Lamps, Panels - Scratch - Medium / Trunk Hood, Rear Gate - Dent - Small / (L) Rear Fender, Molding - Scratch - Small / (L) Rear Door, Molding - Scratch - Small / (L) Front Door, Molding - Scratch & Dent - Minimal / (L) Front Fender, Molding - Scratch - Minimal / (L) Step, In-panel, Side Spoiler - Dent - Minimal / Roof - Dent - Large |
