## General Information

| Make | Mitsubishi | Model | Montero SPT |

## Body / Panel Condition

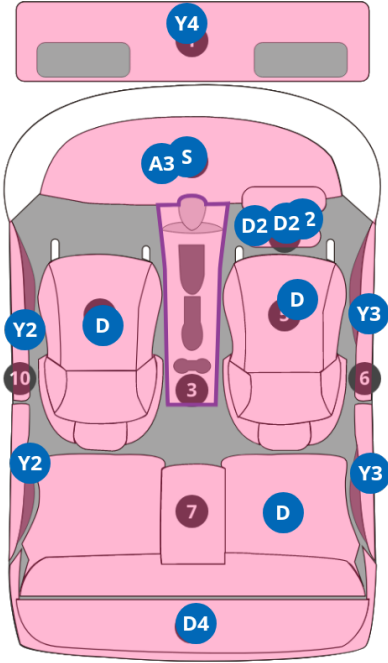
| Interior Evaluation : <b>E</b> | Exterior Evaluation : <b>E</b> |
|---|---|
| <p><b>Remarks</b></p> <p>Overall Interior - Worn as per age - Yes / Overall Interior - Smell - Yes / Trunk Room - Loose, Deformed - Large / Rear Seat - Worn - Yes / (R) Front Seat - Worn - Yes / (L) Front Seat - Worn - Yes / Display, Audio System - Partially Missing - Yes / (L) Front Trim - Grime - Small / (R) Front Trim - Grime - Medium / (R) Rear Trim - Grime - Medium / (L) Rear Trim - Grime - Small / Ceiling - Grime - Large / Dashboard - Worn, Scratch, Cut, Crack - Medium / (L) Front Floor Mat - Worked - Small / (R) Front Floor Mat - Worked - Small / Mat Other - Worked - Small</p> | <p><b>Remarks</b></p> <p>(R) Front Fender - Repair Traces - Yes / (L) Front Fender - Repair Traces - Yes / Trunk Hood, Rear Gate - Repair Traces - Yes / Roof - Repair Traces - Yes / (R) Front Fender, Molding - Scratch - Medium / (R) Mirror - Faded(Color, Gloss) - Yes / (R) Mirror - Scratch - Minimal / (R) Front Door, Molding - Scratch - Large / (R) Rear Door, Molding - Scratch - Medium / (R) Step, In-panel, Side Spoiler - Scratch - Medium / (R) Rear Fender, Molding - Scratch &amp; Dent - Medium / Overall Exterior - Worn as per age - Yes / Rear Bumper, Lamps, Panels - Scratch &amp; Dent - Medium / Trunk Hood, Rear Gate - Scratch &amp; Dent - Large / (L) Rear Fender, Molding - Scratch &amp; Dent - Small / (L) Rear Door, Molding - Scratch &amp; Dent - Small / (L) Step, In-panel, Side Spoiler - Scratch - Medium / (L) Mirror - Scratch - Small / (L) Front Door, Molding - Scratch &amp; Dent - Large / (L) Front Fender, Molding - Scratch - Medium / Front Bumper, Grille, Lamps - Scratch - Large / Bonnet, Headlight - Scratch - Large / Antennae - Damaged - Yes / Roof - Scratch - Large</p> |

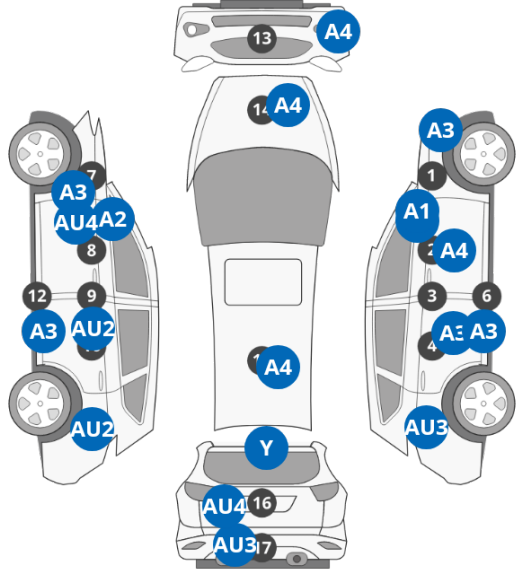
| Inspector Notes |
|---|
| towed unit, mileage cant verify due to panel meter issue, functional can't verify due to non moving unit, no battery, with spare tire, spare key issue, no jack and tools, possible flooding, rear wiper arm missing, antenna missing, console, switch, vent partially missing, suncrack and yellowish headlight and tail light, carpet on trunk room missing, rear door issue, rear seat issue |
