## General Information

| Make | Toyota | Model | Avanza |
| Registration No. | BAH6153 | Chassis No. | MHFAA1BY8S0044913 |

## Body / Panel Condition

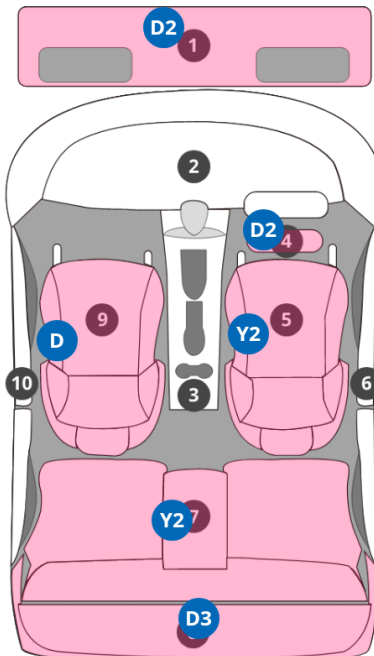
| <div> <div>Interior Evaluation :</div> <div>B</div> </div> | <div> <div>Exterior Evaluation :</div> <div>D</div> </div> |
| <div> <div>Remarks</div> <div>(L) Front Floor Mat - Worked - Small / (R) Front Seat - Grime - Small / (L) Front Seat - Worn - Yes / Ceiling - Crinkle - Small / Rear Seat - Grime - Small / Trunk Room - Loose, Deformed - Medium</div> </div> | <div> <div>Remarks</div> <div>(R) Front Door - Repair Traces - Yes / (R) Mirror - Scratch - Small / (R) Front Fender, Molding - Scratch - Small / (R) Front Door, Molding - Scratch - Small / (R) Rear Door, Molding - Scratch - Medium / (R) Rear Fender, Molding - Scratch &amp; Dent - Small / Rear Bumper, Lamps, Panels - Scratch - Medium / Trunk Hood, Rear Gate - Scratch - Minimal / (L) Rear Fender, Molding - Scratch - Small / (L) Step, In-panel, Side Spoiler - Scratch - Small / (L) Rear Door, Molding - Scratch &amp; Dent - Minimal / (L) Front Door, Molding - Scratch - Small / (L) Mirror - Scratch - Minimal / (L) Front Fender, Molding - Scratch - Minimal / Front Bumper, Grille, Lamps - Crack, Gap - Medium / Bonnet, Headlight - Scratch &amp; Dent - Medium / Roof - Scratch - Small</div> </div> |

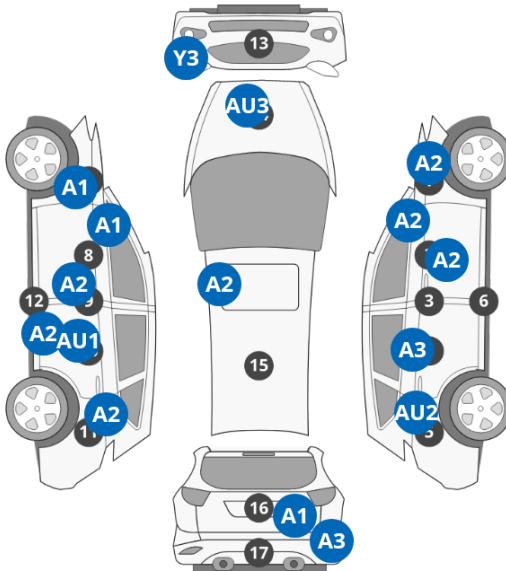
with warranty booklet, no jack and tools, no spare tire, with LTO plate, scratches on tail light, plate light issue, trunk room partially missing
