## General Information

| Make | Toyota | Model | Hiace |
| YOM | 2025 | Odo Meter Reading | 34,178 |
| Registration No. | NJA9627 | Chassis No. | JTFJT02P1S0019723 |

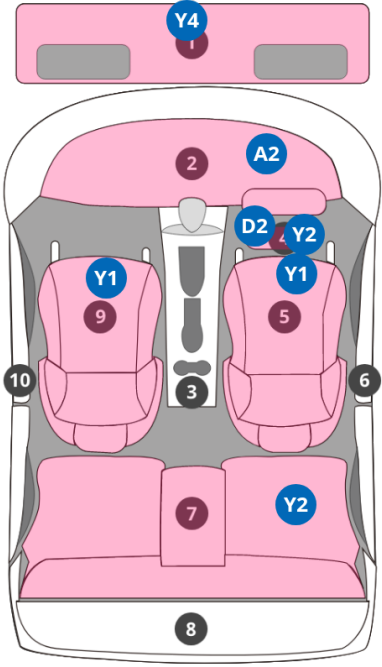
| Interior Evaluation : <b>C</b> | Exterior Evaluation : <b>D</b> |
|---|---|
| <p><b>Remarks</b></p> <p>Ceiling - Grime - Large / (R) Front Floor Mat - Grime - Small / (L) Front Floor Mat - Worked - Small / Dashboard - Worn, Scratch, Cut, Crack - Small / (R) Front Seat - Grime - Minimal / (L) Front Seat - Grime - Minimal / Rear Seat - Grime - Small</p> | <p><b>Remarks</b></p> <p>(R) Rear Door - Repair Traces - Yes / (R) Mirror - Scratch - Minimal / (R) Front Fender, Molding - Scratch - Minimal / (R) Front Door, Molding - Scratch - Small / (R) Center Panel - Scratch - Small / (R) Rear Door, Molding - Scratch - Small / (R) Rear Fender, Molding - Scratch - Medium / Rear Bumper, Lamps, Panels - Scratch - Small / Trunk Hood, Rear Gate - Scratch &amp; Dent - Small / (L) Rear Fender, Molding - Scratch - Medium / (L) Rear Door, Molding - Scratch - Medium / (L) Front Door, Molding - Scratch - Medium / (L) Mirror - Scratch - Minimal / (L) Front Fender, Molding - Scratch - Minimal / Front Bumper, Grille, Lamps - Scratch - Small / Front Panel - Scratch - Minimal / Roof - Scratch - Minimal</p> |

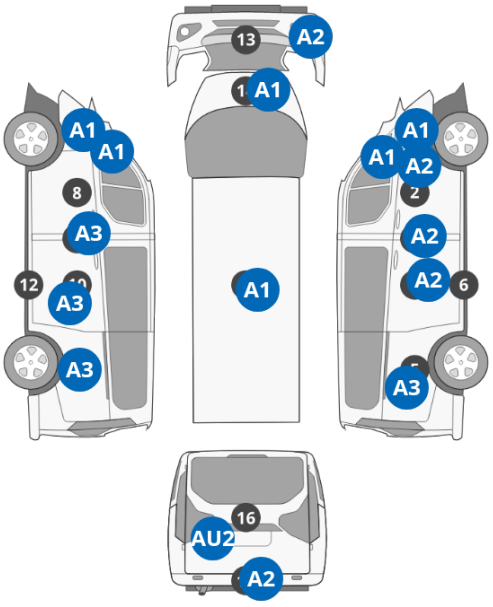
| Inspector Notes |
|---|
| no warranty booklet, with jack and tools, with spare tire, with LTO plate, scratches on headlight and tail light, rear seat loose/nut missing/nit fully attached |
