## General Information

| Make | Toyota | Model | Hilux |
| YOM | 2025 | Odo Meter Reading | 34,146 |
| Registration No. | NKO6560 | Chassis No. | MR0JB8DD7S3236786 |

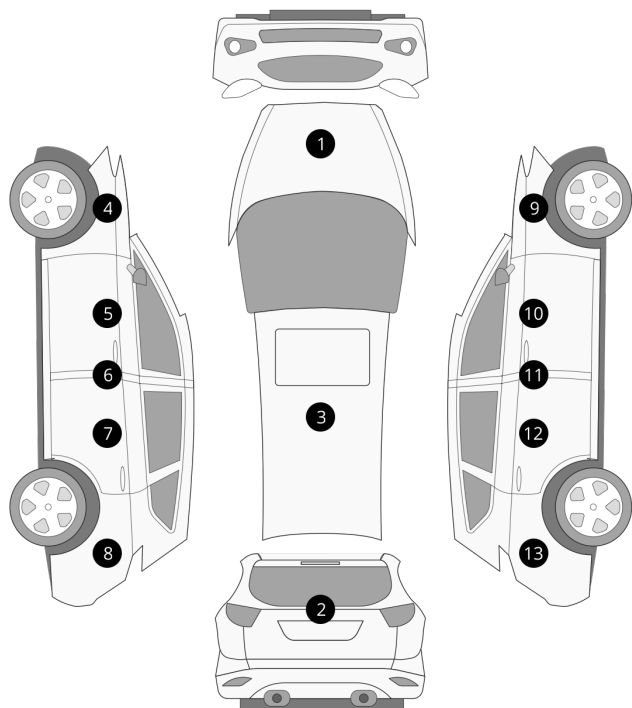
## Body / Panel Condition

| # | Area | Thickness(um) | | | |
| 1 | Bonnet | 113.0 | 111 | 117 | 111 |
| 2 | Boot Lid | 101.0 | 101 | 100 | 102 |
| 3 | Roof | 96.9 | 93 | 96 | 94/105 |
| 4 | Left Front Fender | 98.9 | 96 | 102 | 99 |
| 5 | Left Front Door | 96.6 | 89 | 97 | 104 |
| 7 | Left Rear Door | 100.4 | 107 | 95 | 99 |
| 8 | Left Back Panel | 95.2 | 92 | 100 | 94 |
| 9 | Right Front Fender | 104.2 | 94 | 110 | 109 |
| 10 | Right Front Door | 102.2 | 116 | 97 | 94 |
| 12 | Right Rear Door | 97.5 | 100 | 89 | 104 |
| 13 | Right Back Panel | 99.2 | 96 | 108 | 94 |

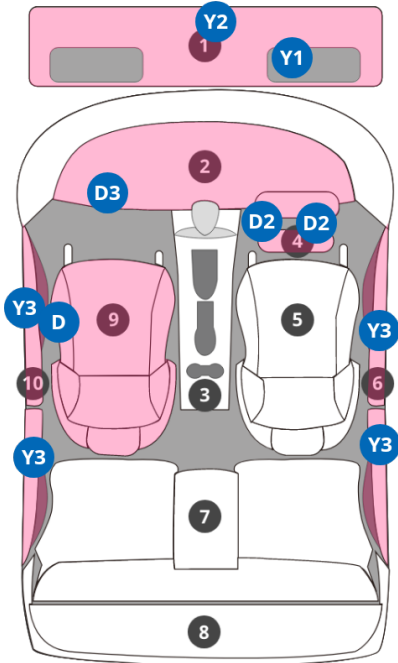
| Interior Evaluation : <b>D</b> | Exterior Evaluation : <b>D</b> |
| <p><b>Remarks</b><br/>(L) Front Trim - Grime - Medium / (L) Rear Trim - Grime - Medium / (R) Rear Trim - Grime - Medium / (R) Front Trim - Grime - Medium / (L) Front Seat - Worn - Yes / Ceiling - Grime - Small / Sunvisor, Sunglass Holder - Grime - Minimal / Dashboard - Loose, Deformed - Medium / (R) Front Floor Mat - Worked - Small / (L) Front Floor Mat - Worked - Small</p> | <p><b>Remarks</b><br/>Front Bumper, Grille, Lamps - Scratch - Large / Roof - Scratch - Medium / Rear Bumper, Lamps, Panels - Scratch - Medium / (R) Front Fender, Molding - Scratch - Minimal / (R) Mirror - Scratch - Minimal / (R) Front Door, Molding - Scratch - Small / (R) Step, In-panel, Side Spoiler - Scratch - Small / (R) Rear Door, Molding - Scratch - Small / (R) Side Gate - Scratch - Small / Rear Gate - Scratch &amp; Dent - Small / Cargo Bed Floor - Crack, Gap - Small / (L) Side Gate - Scratch - Small / (L) Rear Door, Molding - Scratch - Minimal / (L) Step, In-panel, Side Spoiler - Scratch - Small / (L) Front Door, Molding - Scratch - Minimal / (L) Front Fender, Molding - Scratch - Minimal / Bonnet, Headlight - Scratch - Small / (L) Mirror - Scratch - Minimal</p> |
