## General Information

| Make | Toyota | Model | Hilux Tamaraw |
| Registration No. | NKU2218 | Chassis No. | PAHACACA1S6425612 |

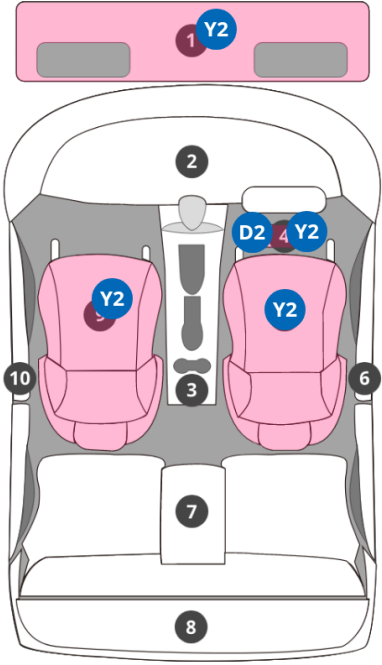
| Interior Evaluation : <b>B</b> | Exterior Evaluation : <b>E</b> |
|---|---|
| <b>Remarks</b><br>(R) Front Seat - Grime - Small / (L) Front Seat - Grime - Small / Ceiling - Grime - Small / (R) Front Floor Mat - Grime - Small / (L) Front Floor Mat - Worked - Small | <b>Remarks</b><br>(R) Front Fender, Molding - Scratch - Small / (R) Mirror - Scratch - Small / (R) Step, In-panel, Side Spoiler - Scratch - Small / (R) Front Door, Molding - Scratch - Small / (R) Side Gate - Scratch & Dent - Large / Rear Bumper, Lamps, Panels - Scratch - Large / Cargo Bed Floor - Scratch - Large / Rear Gate - Scratch & Dent - Small / (L) Side Gate - Scratch & Dent - Large / (L) Front Door, Molding - Scratch & Dent - Large / (L) Step, In-panel, Side Spoiler - Scratch - Small / (L) Mirror - Scratch - Minimal / (L) Front Fender, Molding - Scratch - Minimal / Bonnet, Headlight - Scratch - Minimal / Front Bumper, Grille, Lamps - Scratch - Medium / Roof - Dent - Medium |
