## General Information

| Make | Toyota | Model | Hilux Tamaraw |
| YOM | 2025 | Odo Meter Reading | 34,843 |

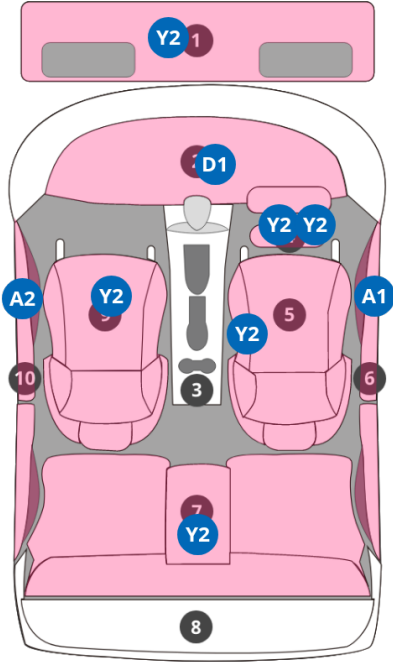
| Interior Evaluation : <b>B</b> | Exterior Evaluation : <b>E</b> |
| <p><b>Remarks</b></p> <p>(L) Front Seat - Grime - Small / (R) Front Seat - Grime - Small / (L) Front Floor Mat - Grime - Small / (R) Front Floor Mat - Grime - Small / (L) Front Trim - Cut, Crack - Small / (R) Front Trim - Cut, Crack - Minimal / Ceiling - Grime - Small / Rear Seat - Grime - Small / Dashboard - Worked - Minimal</p> | <p><b>Remarks</b></p> <p>Bonnet - Repair Traces - Yes / (L) Rear Corner Panel - Repair Traces - Yes / (R) Front Fender, Molding - Scratch &amp; Dent - Small / Bonnet, Headlight - Scratch &amp; Dent - Small / (L) Front Fender, Molding - Scratch &amp; Dent - Small / (L) Front Door, Molding - Scratch &amp; Dent - Small / (L) Side Gate - Scratch &amp; Dent - Medium / (L) Guard Frame - Scratch &amp; Dent - Small / (L) Guard Frame - Repair mark - Yes / (R) Guard Frame - Scratch &amp; Dent - Medium / (R) Side Gate - Scratch &amp; Dent - Small / (R) Front Door, Molding - Scratch &amp; Dent - Small / Roof - Scratch &amp; Dent - Small / Front Bumper, Grille, Lamps - Scratch - Small / (R) Side Gate - Repair mark - Yes / Cargo Bed Floor - Scratch - Medium / Rear Bumper, Lamps, Panels - Scratch - Small / Rear Gate - Scratch &amp; Dent - Small</p> |

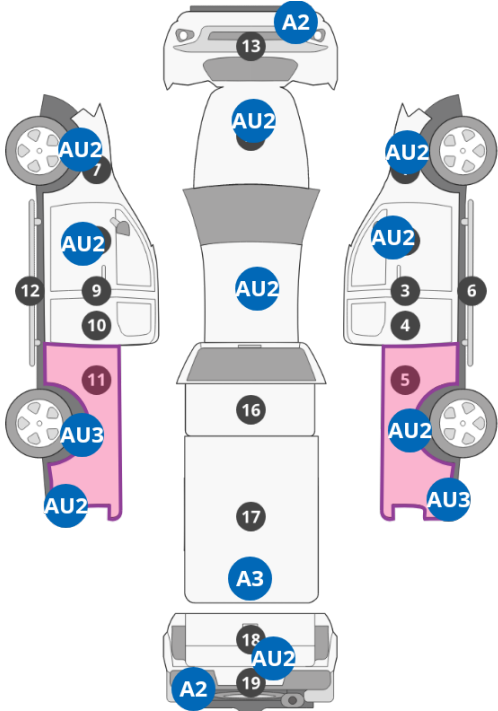
| Inspector Notes |
|---|
| <p>with LTO plate, with jack, with spare tire and key, with manual and warranty booklet, scratches on exterior, check engine indicator on, scratches on taillight and headlight, no reverse camera, maintenance indicator on.</p> |
