## General Information

| Make | Toyota | Model | Hilux Tamaraw |
| Registration No. | DCD1437 | Chassis No. | PAHACACA7S6422472 |

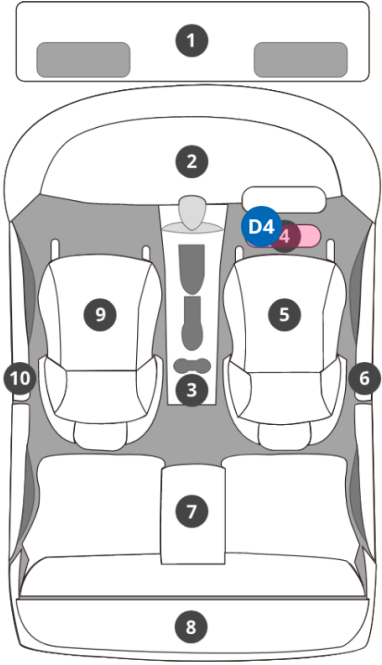
| Interior Evaluation : <span style="color: red; font-weight: bold;">C</span> | Exterior Evaluation : <span style="color: red; font-weight: bold;">D</span> |
|---|---|
| <b>Remarks</b><br>(L) Front Floor Mat - Worked - Large | <b>Remarks</b><br>(L) Side Gate - Scratch & Dent - Medium / Cargo Bed Floor - Scratch & Dent - Large / Rear Gate - Scratch & Dent - Small / (R) Side Gate - Scratch & Dent - Large / Front Bumper, Grille, Lamps - Scratch & Dent - Large / (R) Front Door, Molding - Scratch - Small / Roof - Scratch - Medium / Cab Back Panel - Scratch & Dent - Large |
