## General Information

| Make | Toyota | Model | Vios |
| Registration No. | CCQ2447 | Chassis No. | PA1B18F3XS4291953 |

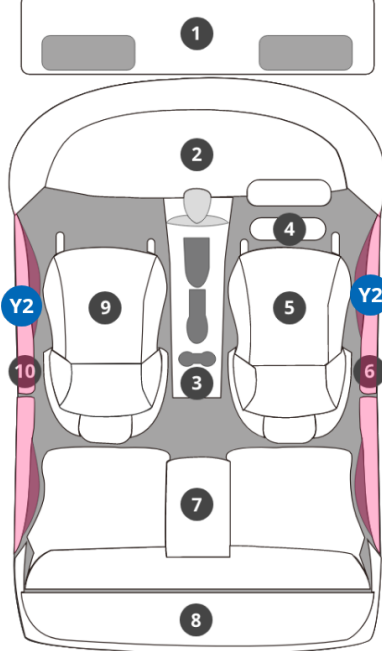
| Interior Evaluation : <span style="color: red; font-weight: bold;">A</span> | Exterior Evaluation : <span style="color: red; font-weight: bold;">E</span> |
| <p><b>Remarks</b><br/>(L) Front Trim - Grime - Small / (R) Front Trim - Grime - Small</p> | <p><b>Remarks</b><br/>(R) Front Fender - Repair Traces - Yes / Bonnet - Repair Traces - Yes / (L) Front Fender - Repair Traces - Yes / (R) Rear Fender, Molding - Scratch &amp; Dent - Large / Rear Bumper, Lamps, Panels - Scratch - Large / (L) Rear Fender, Molding - Dent - Small / (L) Rear Door, Molding - Scratch - Small / (L) Front Door, Molding - Scratch - Small / Front Bumper, Grille, Lamps - Scratch - Medium / (R) Step, In-panel, Side Spoiler - Scratch &amp; Dent - Medium / (R) Front Door, Molding - Scratch - Medium / Bonnet, Headlight - Scratch - Small / (L) Front Fender, Molding - Scratch - Small / (R) Front Fender, Molding - Scratch - Small / Trunk Hood, Rear Gate - Scratch - Small</p> |
