## General Information

| Make | Suzuki | Model | Dzire |
| Registration No. | NFS4150 | Chassis No. | MBHZF63S5RG467841 |

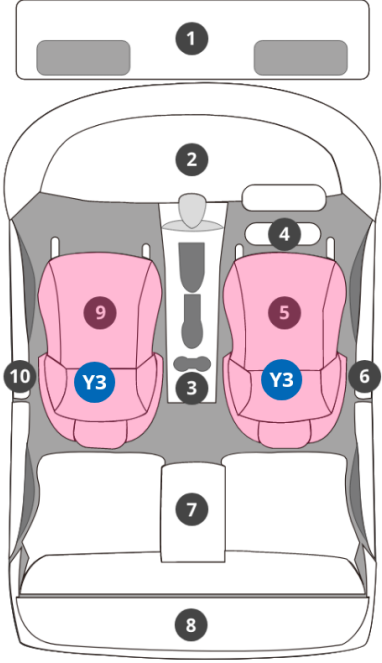
| Interior Evaluation : <b>B</b> | Exterior Evaluation : <b>C</b> |
|---|---|
| <b>Remarks</b><br>(R) Front Seat - Grime - Medium / (L) Front Seat - Grime - Medium | <b>Remarks</b><br>(R) Front Fender, Molding - Scratch & Dent - Small / (R) Rear Door, Molding - Scratch & Dent - Large / (R) Front Door, Molding - Dent - Small / (R) Rear Fender, Molding - Scratch & Dent - Medium / Rear Bumper, Lamps, Panels - Scratch - Small / (L) Rear Fender, Molding - Scratch & Dent - Minimal / (L) Front Fender, Molding - Scratch & Dent - Small / Front Bumper, Grille, Lamps - Scratch & Dent - Medium / Bonnet, Headlight - Scratch - Small |
